# Mpofana River Walk Report

23rd to 25<sup>th</sup> September 2014

Compiled by Penny Rees  
Duzi uMngeni Conservation Trust  
(DUCT)  
February 2015

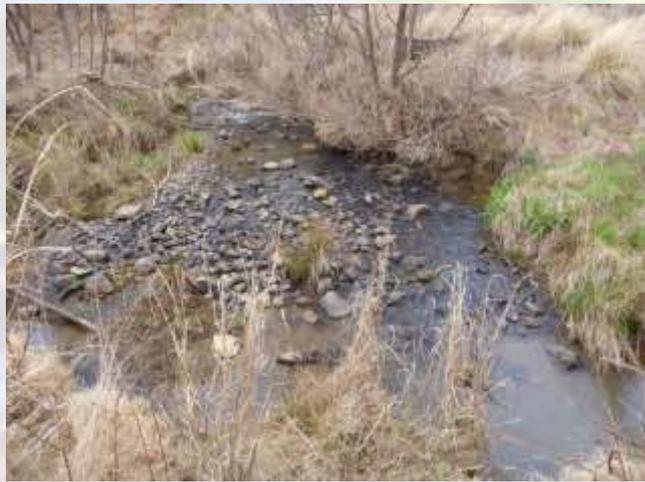
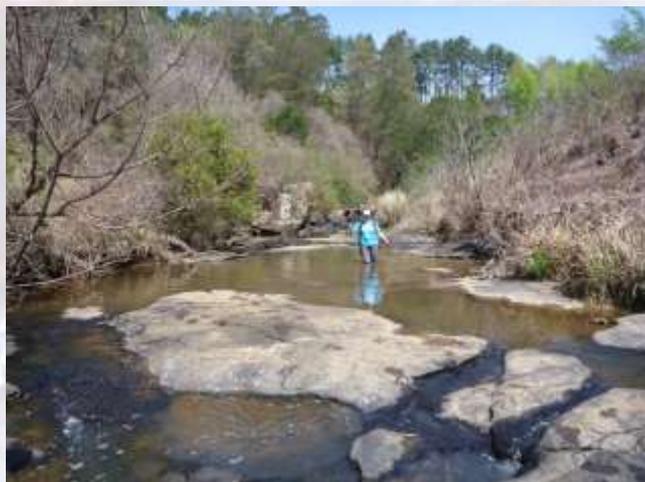
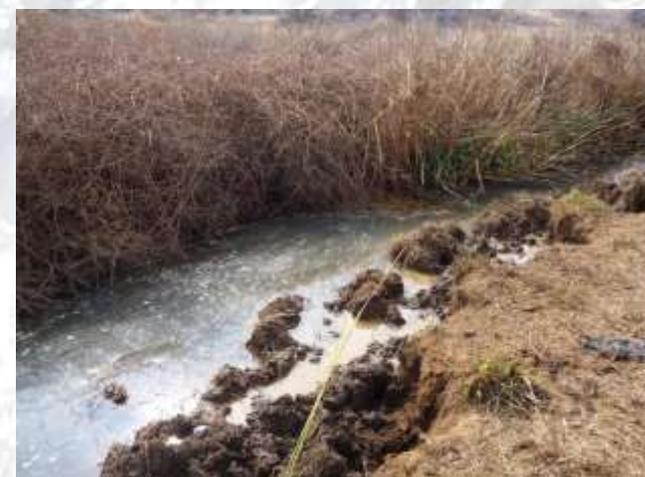
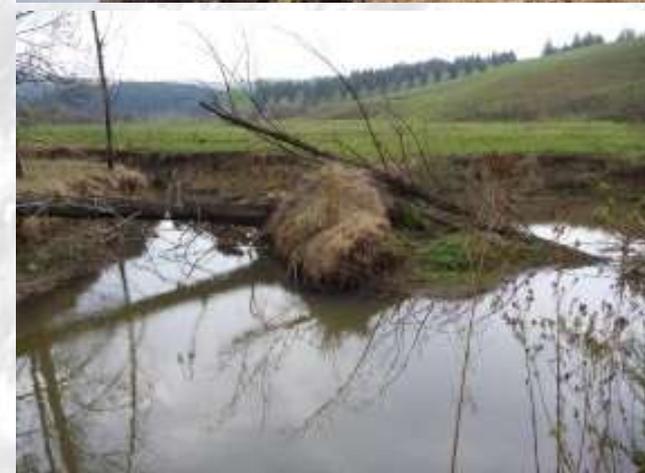
*Lower Middle: Localised erosion from cattle trampling*

*Bottom: Bank erosion from high flows of Mooi Outfall*

Natural erosion takes place in the meandering incised river channels. Erosion from livestock accessing the river caused localised turbidity and siltation on the bed of the Mpopana, however river bank collapse from the abnormal constant high flows of the Mooi uMngeni Transfer Scheme is a far greater impact

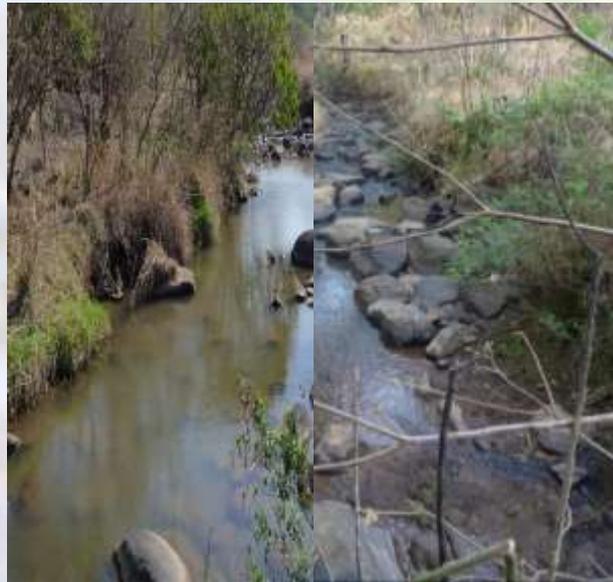
Thirteen kilometres from its source, having meandered for +2,5 kilometres across a floodplain, the Mpopana reaches the Mooi outfall which is situated at a right angle to the water course and is a mere 600 metres upstream of the end of the floodplain. The banks on the floodplain upstream of the outfall have vegetative cover and lack signs of excess erosion.

*Top: (left) Turbid water downstream of outfall; (right) clear water upstream of outfall*

*Upper Middle: MMTS outfall point*

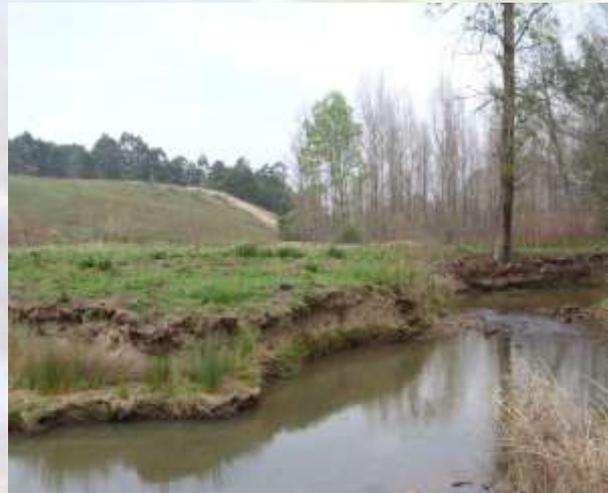
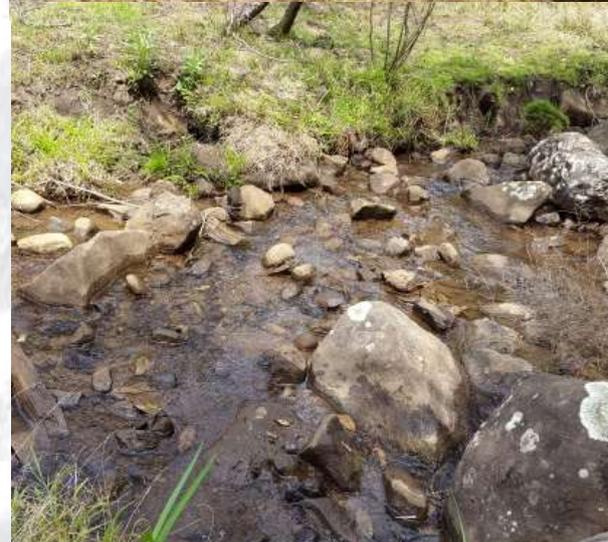
There is no doubt in our minds that the erosion of the Mpopfana banks has been accelerated by the waters of the transfer scheme.

*Top: Eroded banks downstream of outfall  
Upper Middle: Fence over eroded bank  
Lower Middle: Typical silted river downstream of outfall  
Bottom: Typical clear water upstream of outfall*

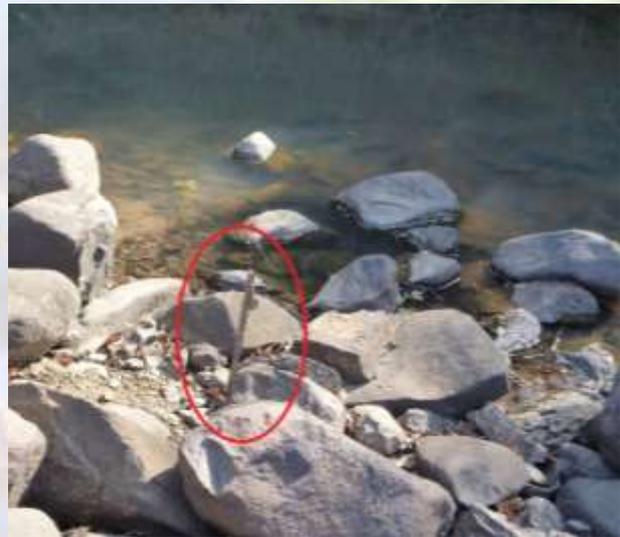
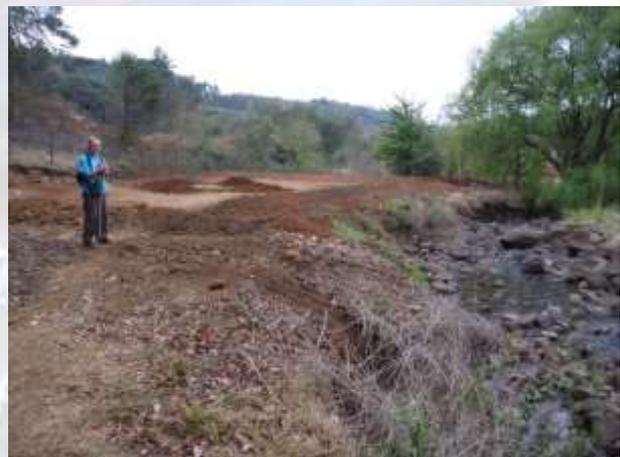
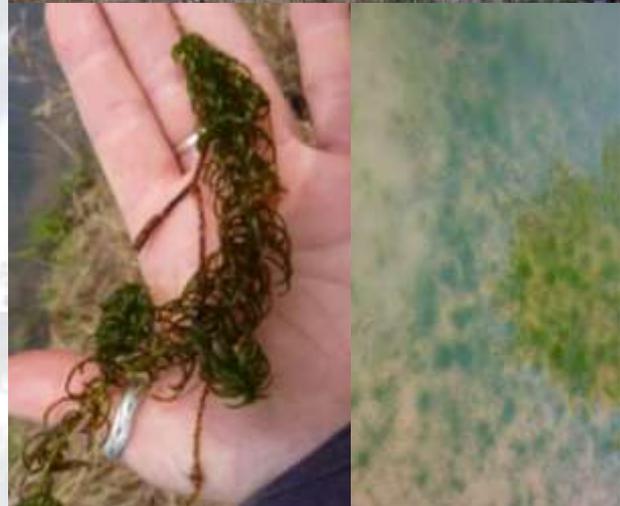
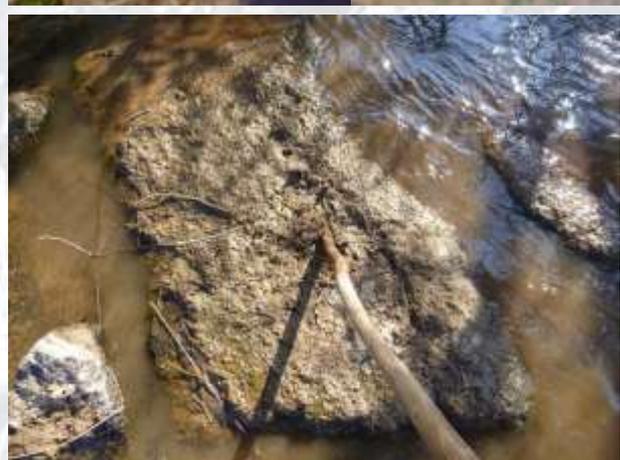
As mentioned earlier, at the inception of Phase 1 of the scheme, attempts were made to monitor the impacts of the transferred water. This was done by placing metal stakes on the edge of the river bank. Unfortunately it seems as though most of these stakes have fallen into the river as the banks have eroded and collapsed – we only saw one stake along the river. Being unpainted, they are also difficult to spot.

The aforementioned burial ground site has resulted in a large area of earth being cleared of all vegetative cover which will wash into the river with hard rain and could collapse / wash away with the future increased flows.

*Top: Erosion monitoring peg (circled)*  
*Upper Middle: Burial ground site*  
*Lower Middle: Oxygen Weed & algal bloom*  
*Bottom: Elevated level of silt*

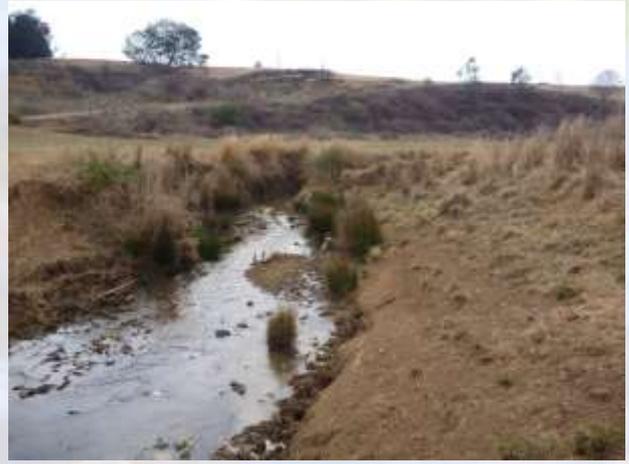
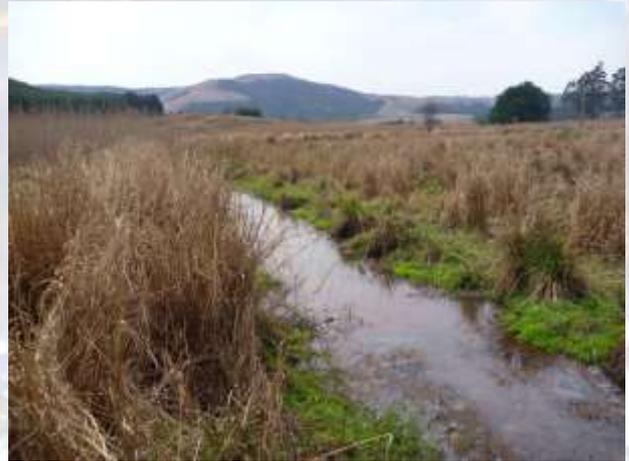
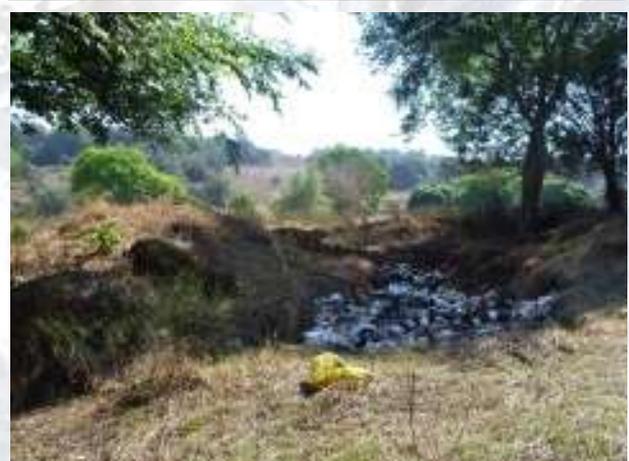
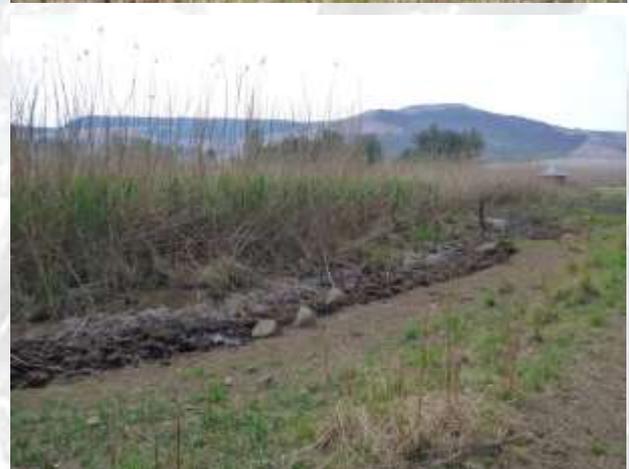
*Wetland adjacent to Zenzanani Village:* crossed by a a rock “causeway” road (pipeline servitude)

*Bottom: Cattle trampling of wetland buffer*

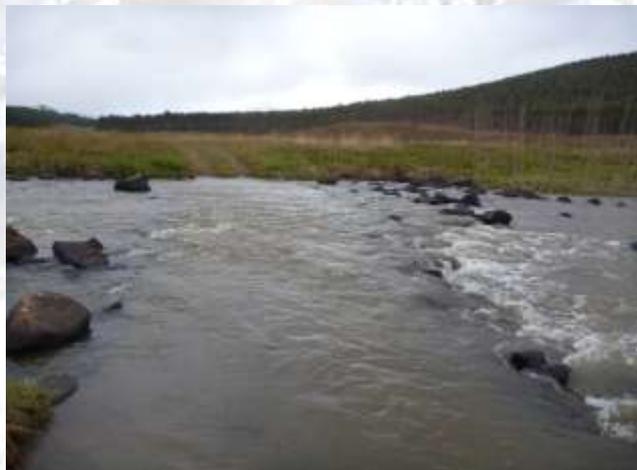
*Photo: Flooded causeway on Lions River during MMTS release, September 2013*

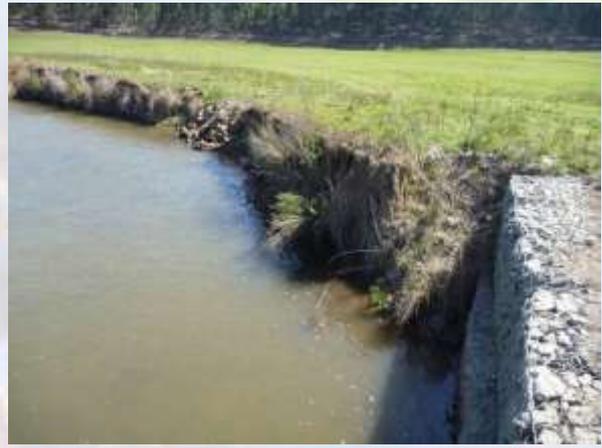
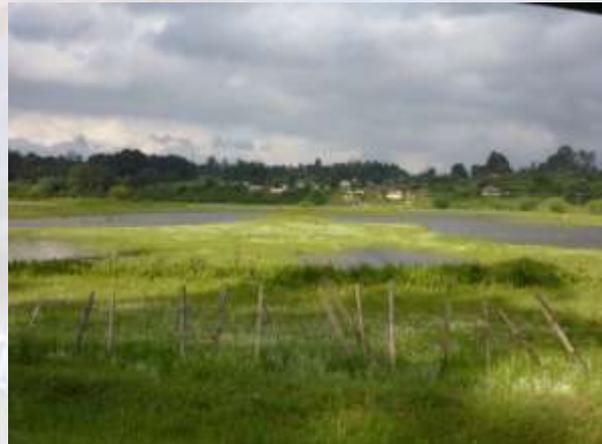
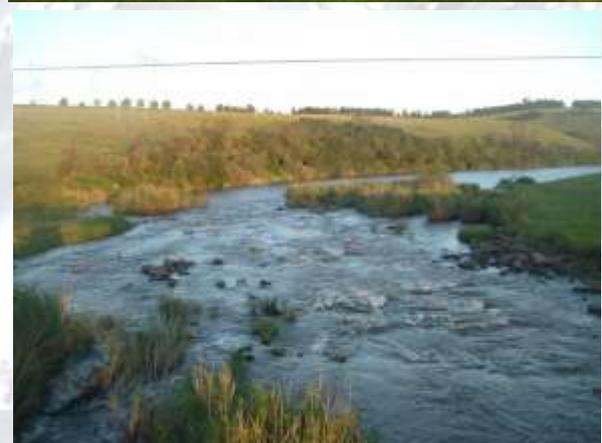
such an extent that stone gabions are being used in places to shore up the banks. This is meeting only limited success, and it seems that the meandering river is eroding and many of the meanders will disappear as the water finds the easiest, most direct path, re-routing the river to a straighter course. Apart from the ill effects that this is or will have on the rivers health, such a straightening route will exacerbate downstream flooding and its dangers as the water, instead of spilling over the banks and dissipating onto the flood plain, will flood down the channel towards Midmar Dam at ever increasing speeds and force. The inlet / head waters of Midmar Dam has been identified as an important Fish Breeding site for the endemic Natal Yellowfish & we wonder if and how all this silt is impacting the breeding site.

*Top: Gabion & eroding bank – Lions River floodplain d/s of Mpopana Sept 20013  
Middle: Lions River spilling over onto floodplain (Lidgetton area) December 2013  
Bottom: Midmar Dam fish breeding area February 2005*

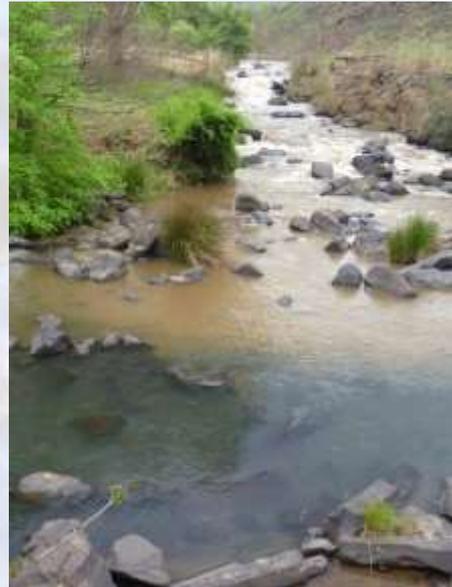
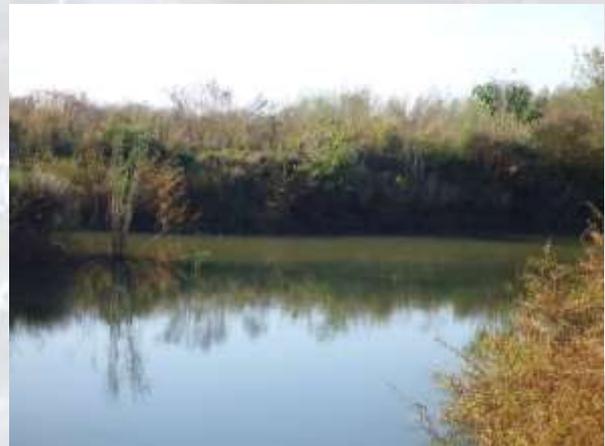
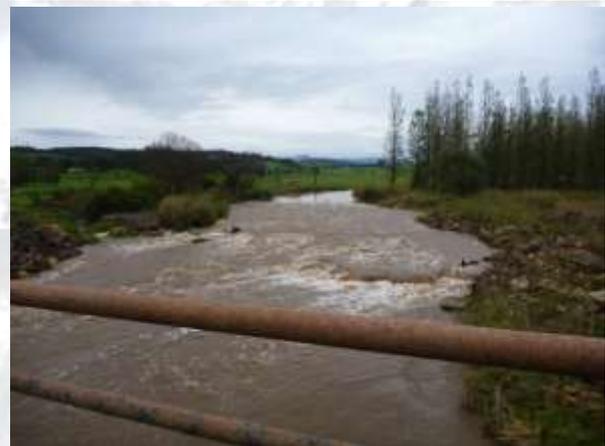
*Top: Silted Mpofana entering clear Lions during MMTS transfer, September 2013. No recent rains in catchment*

*Middle: Silted Lions entering clear uMngeni, May 2012. No recent rains in catchment*
