Aller River Walk Report

6th & 7th November 2015

Compiled by Penny Rees
Duzi uMngeni Conservation Trust (DUCT)
December 2015

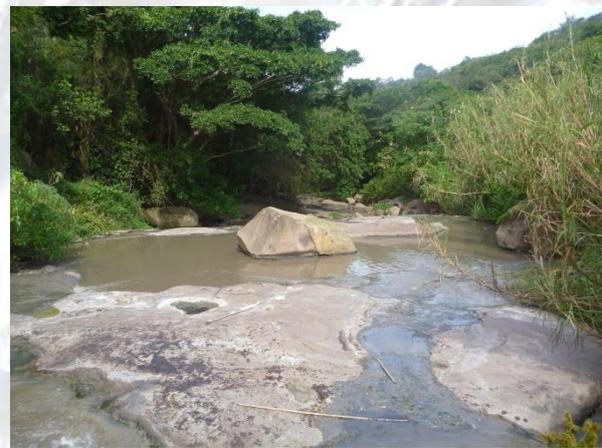
Lower Middle: Sewage in the lower reaches of the Aller

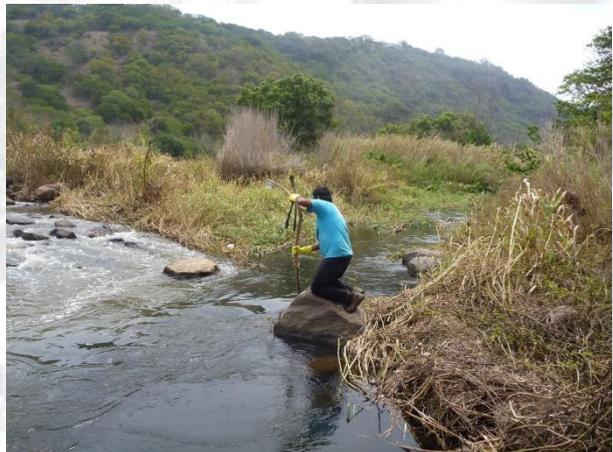
Small isolated piles of plastic rubbish lie on the banks in places – testimony to the high floods that rush down the valley during summer rains that are exacerbated by all the urban storm water flows which find their way into the river. As the Aller bursts out of the valley, channelled in a small flood plain completely smothered in invasive Spanish Reeds, the water is finally clear. But one last surcharging manhole ensures that the Aller is once again completely grey and contaminated with sewage when the waters meet with the clear uMngeni River.

Bottom: Aller / uMngeni confluence

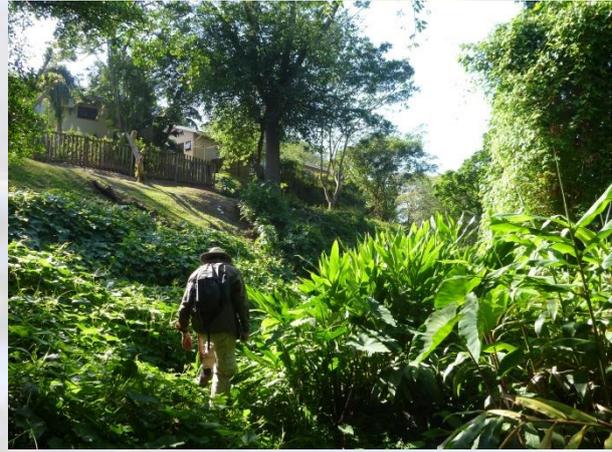
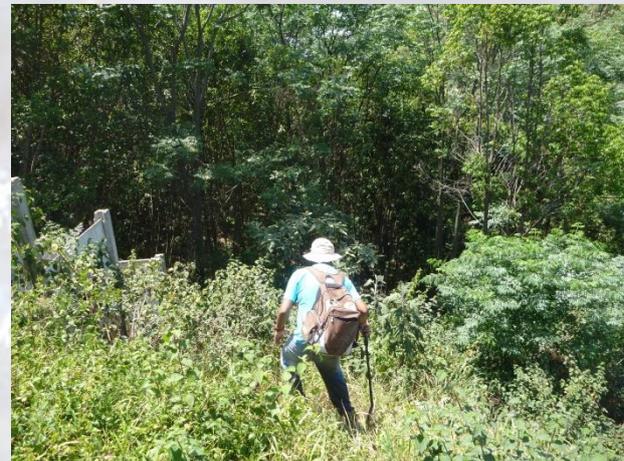
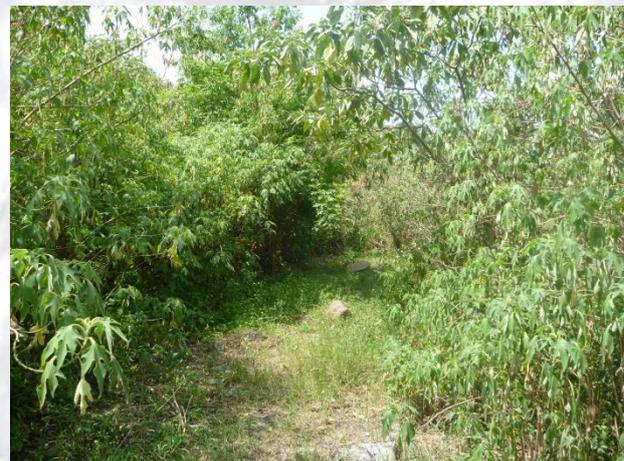
Top: Suburbia - Garden, lawn; Madumbi, Ginger, Sou Sou, Moon Vine on river banks
Middle: Industrial area - Indian Laurel forest, Syringa, Bug weed and Cromolaena
Bottom: Near New Germany WWTW - Mexican Sunflower, Bug weed, Eucalyptus

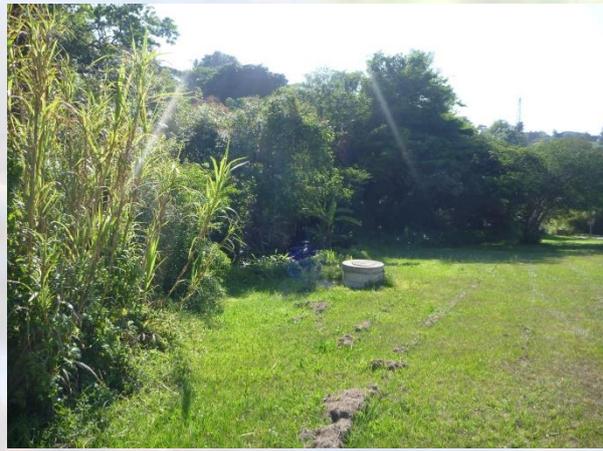
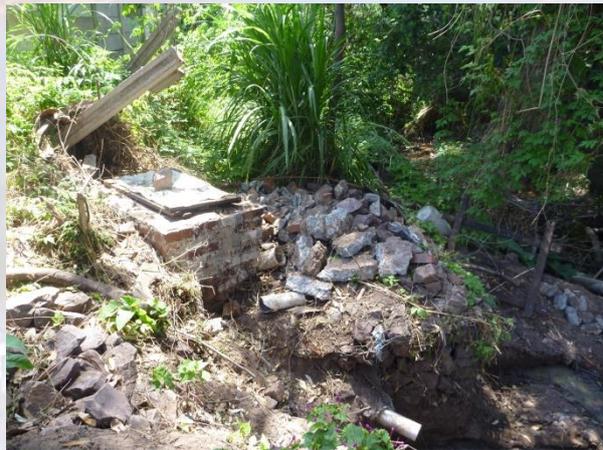
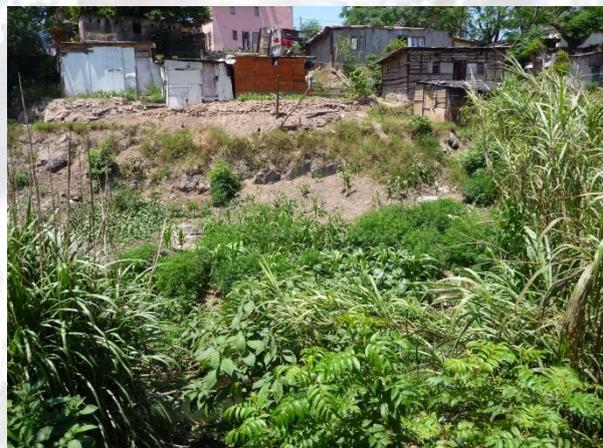
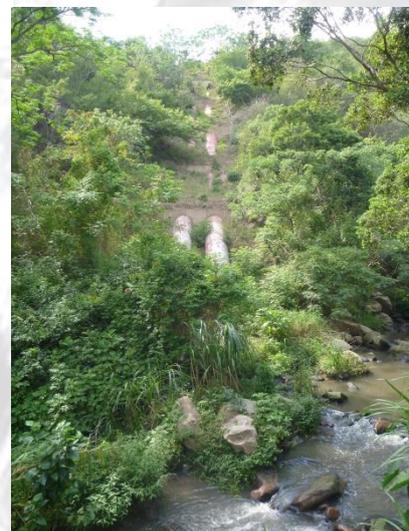
- A buried main sewer line runs on the left bank almost constantly from the source to close to the uMngeni River confluence. There is either lawn or a cleared vehicle inspection access route on top of the pipeline for most of the length of the Aller. Raised manhole access points are situated approximately every 50 to 100 metres along the length of the river.
- Eleven causeways, eleven road bridges and seven pipelines cross the river
- Downstream of the source, there are some places where the river banks have either houses and or gardens in the buffer (Ghait Road to Sander Road waypoints 49 - 45.5)
- In the industrial area, buildings and parking grounds are situated in the buffer
- Some small kitchen gardens were observed on the river banks upstream of the New Germany WWTW

Top: Suburbia – manhole & public area lawn in buffer

Upper Middle: Industrial – construction and dumping

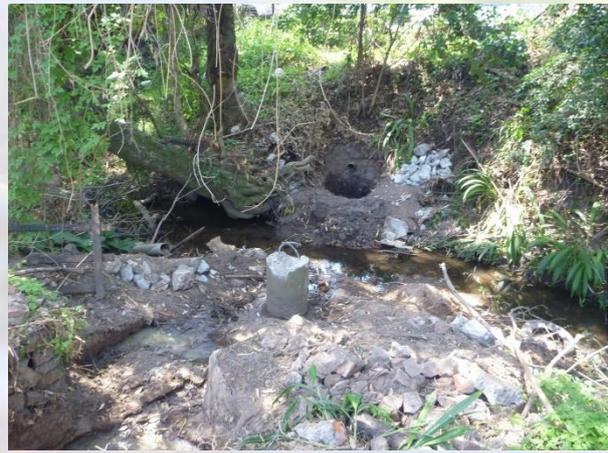
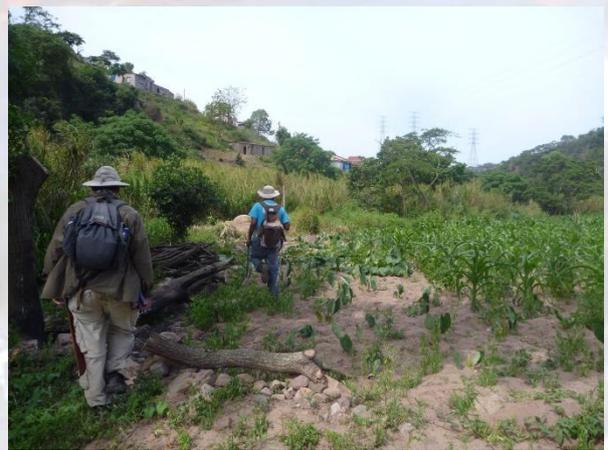
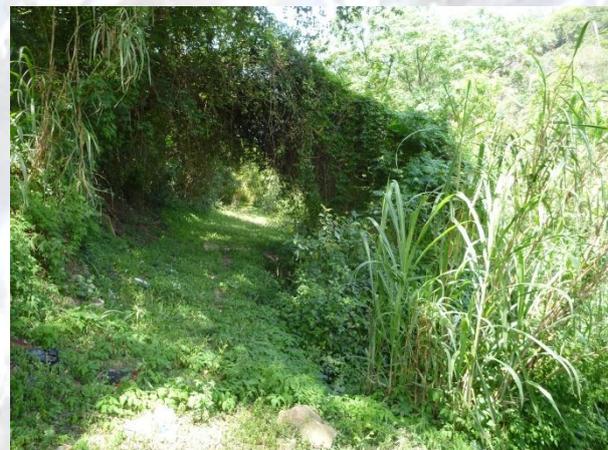
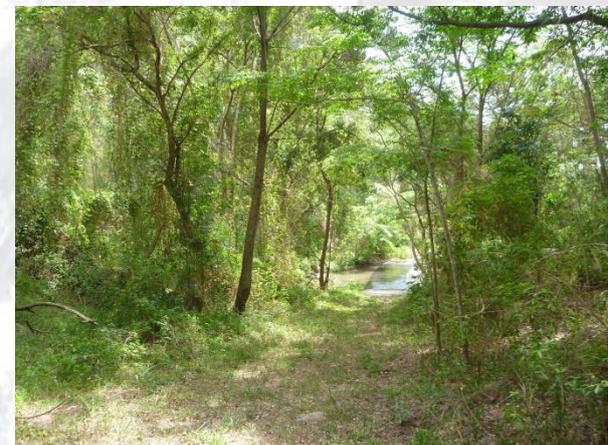
Top: Erosion potential, industrial area

Upper Middle: Erosion potential, lower end of Clermont

Bottom: Access track and causeway, lower reaches near confluence

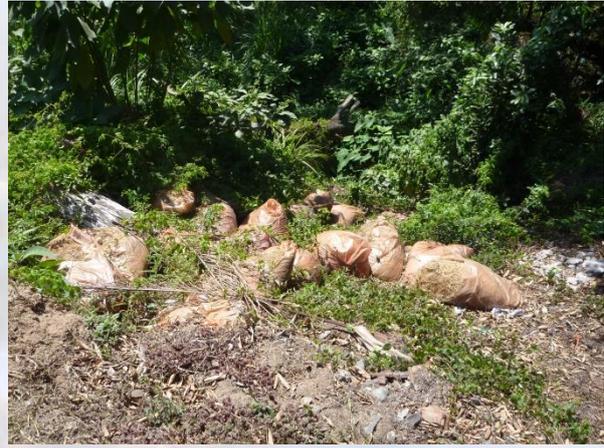
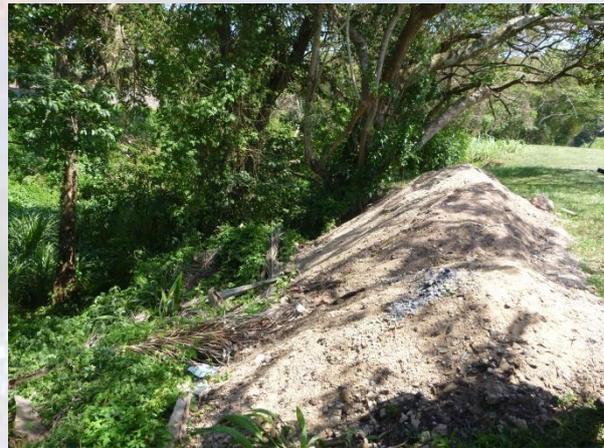
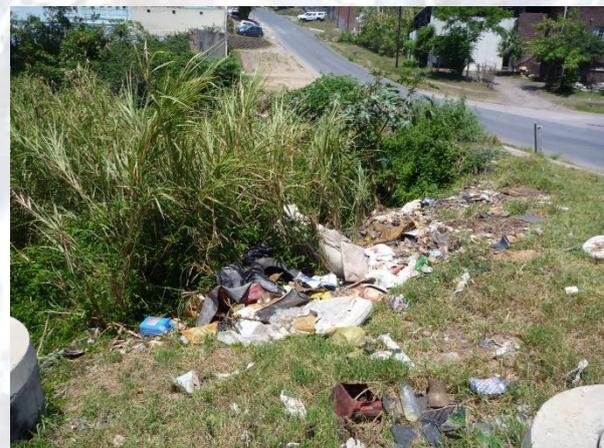
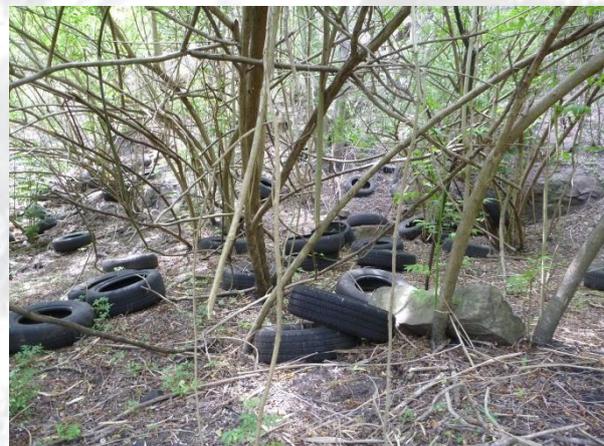
- In the informal settlements where there is apparently no municipal waste disposal, household waste is thrown over the river banks.
- In the township, general waste was dumped onto the river bank or into the river and occasionally burnt.

- In the rural area some burn-pits were observed close to the river.
- 200 metres upstream of the Aller / uMngeni confluence a pile of old vehicle tyres lies on the river bank at the foot of a steep hill slope topped by cliffs. Some tyres are wedged in trees and it is evident that the tyres have been thrown off the top of the cliff some 50 metres above the river seemingly from open ground between two suburban properties on Annet Drive.

Top: Suburban garden waste dumping

Upper Middle: Suburban dumping

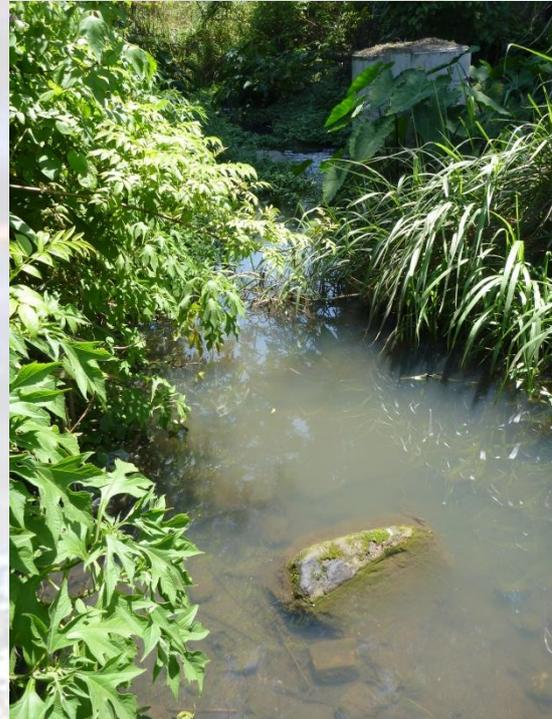
Between waypoints 33 and 27 one manhole was observed surcharging raw sewerage into the Aller River and a total of six manholes showed evidence of recent surcharges (wet faeces pooled and dried faeces stacked around and against the manholes or making a black trail away from the relevant manhole towards the river).

Top: Waypoint 38 – sewage smell and algal bloom. Manhole with signs of surcharge
Bottom: Waypoint 31 – dried excrement from surcharge

Sewer Monitors: We observed that the pipeline path from way points 33 to +- 24.5 has been kept cut open. In areas where there are no nearby homes, a local resident/s could be appointed to walk / ride a bicycle daily along given lengths of this pathway to inspect the pipeline and report any surcharges

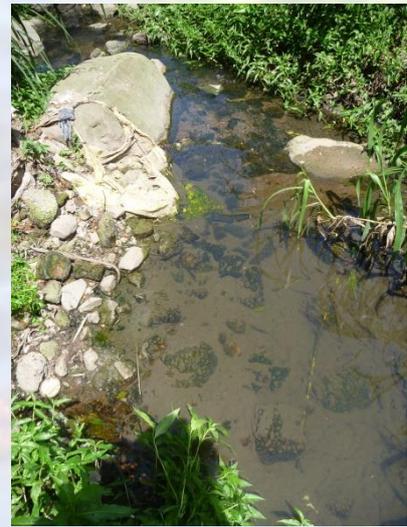
At the upper end of the New Germany WWWTW (waypoint 32) there were heavy loads of sludge (diatoms) on the river bed and submerged rocks, and there were also clumps of algae.

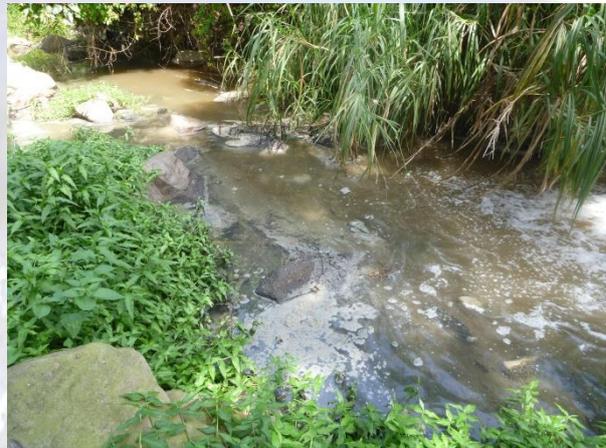
By waypoint 22.5 the river water had finally become clear and had no smell of sewage, but 200 metres downstream of this at waypoint 21.5, a second manhole was surcharging into the river. We left the river not far below this point and re-joined it at waypoint 10 by which time the turbidity was still evident, but less than at the previous surcharging manhole.

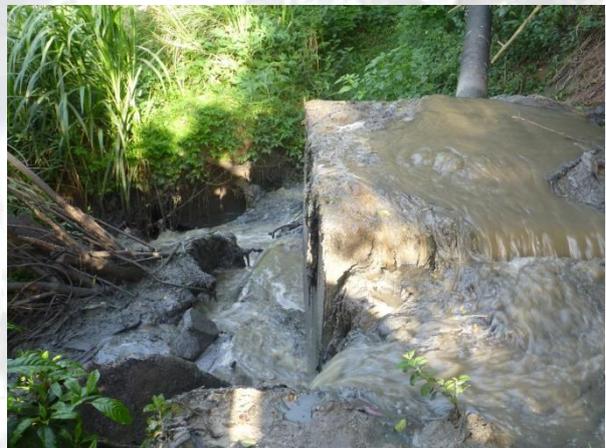
The turbidity of the river gradually lessened until waypoint 1 which although still turbid, was bordering on clear. By the time the Aller reached its confluence 200 metres downstream, it was again 100% turbid grey with sewage.

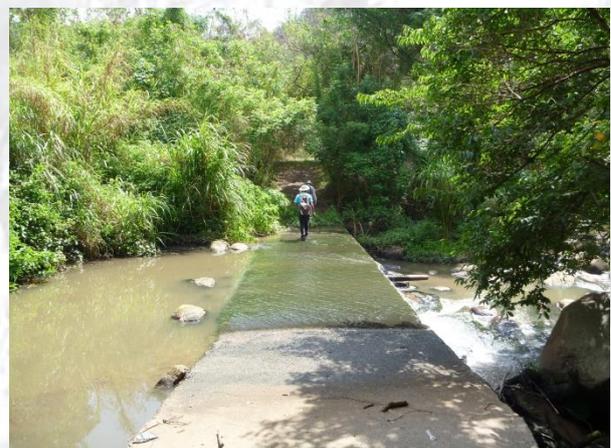
The pipeline servitude track mentioned above crosses the river by means of a series of ten causeways. All these causeways have large pipes built into them which prevent complete damming of the river, however they do effectively slow the flow of the river.

Photo: Typical causeway in the lower reaches of the Aller

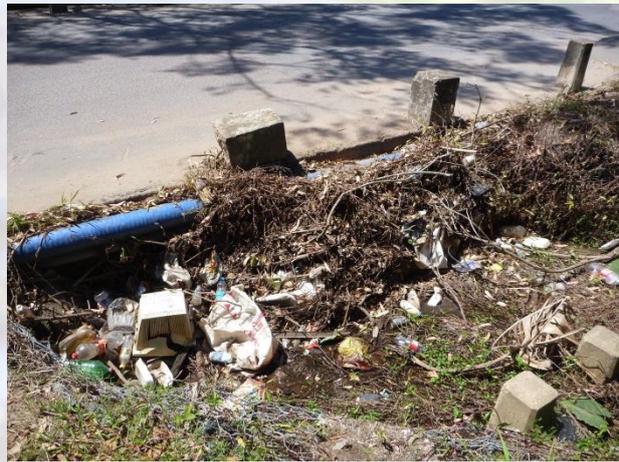
- The low level bridge in Janine Road is blocked up by litter that has been washed downstream
- Dumping into the river takes place in the industrial area where vehicles can access the river
- In the lower reaches of the Aller, plastic waste carried by high flood levels is left behind on the banks by receding floodwaters

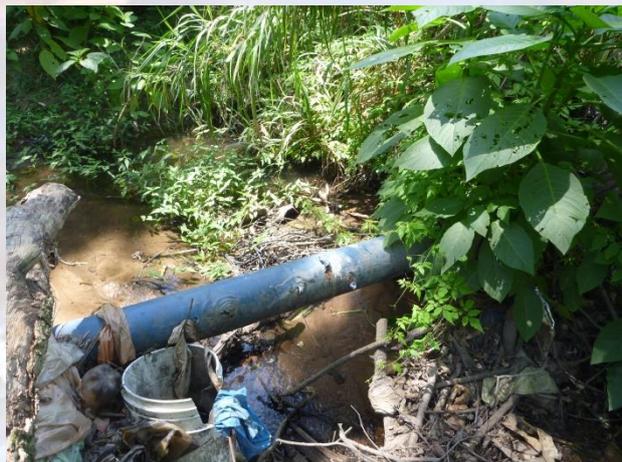
Construction for an unknown reason was taking place in a section of the Aller river bed at the start of the industrial area

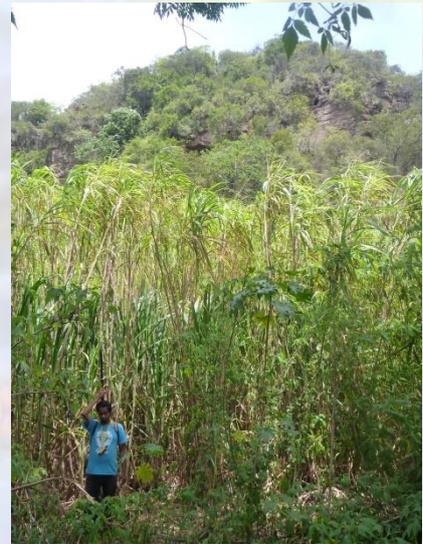
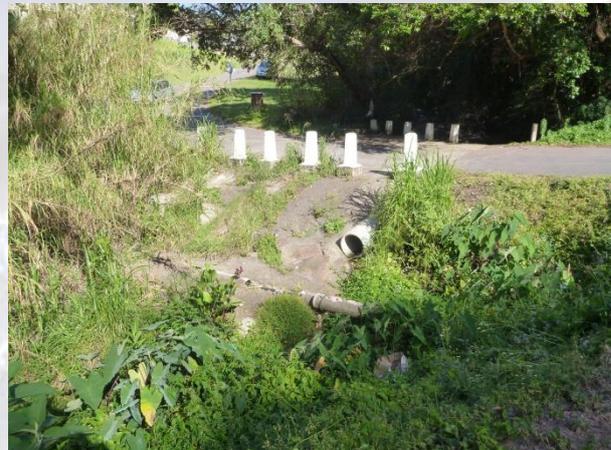
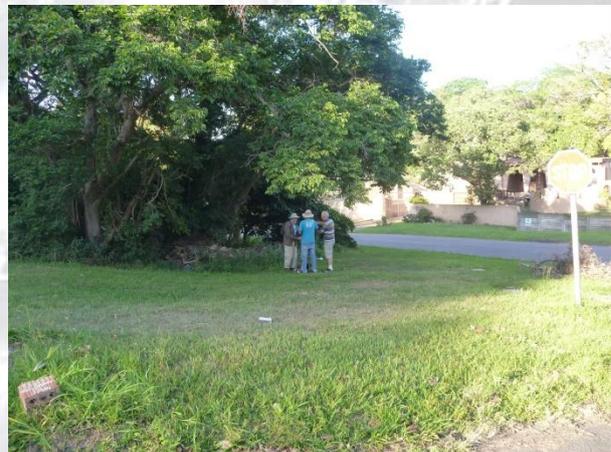
The source of the Aller is a small bowl shaped depression in an urban environment adjacent to a junction of three roads that slope steeply towards the source basin. This results in the river being the receiving point for large quantities of storm water from the surrounding area which will have the impact of scouring the river bed. Thus the likely causes of the low river health score so close to the source are most likely to be

- invisible contaminants entering the river via roads and storm water (for example herbicides and pesticides from neighbouring gardens; toxins from passing vehicles – drips, leaks and emissions)
- scouring action of storm water flows

Middle: Storm water entry point at causeway, waypoint 49

Bottom: Source – storm water receptacle

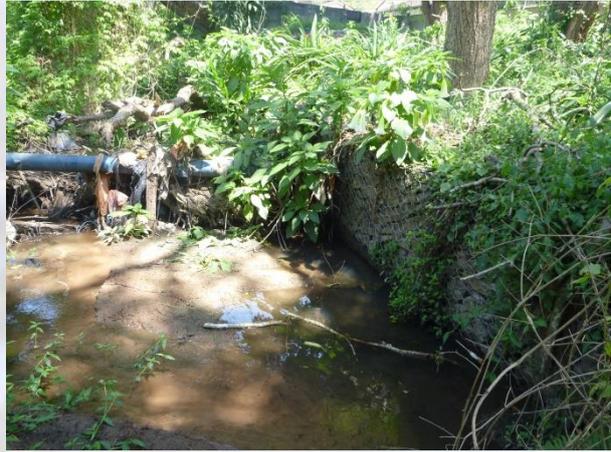
Some siltation of the river bed between Chait Close and Janine Road (waypoints 49 and 45.5) as well as in the industrial area downstream of Berkshire road (+ waypoint 43) was observed. This occurrence, in conjunction with stone gabions, some eroded banks plus river banks of +- 3 or more metres high indicates that erosion is taking place, most likely exacerbated by the scouring effect of storm water flows originating from surrounding paved surfaces may be impacting the upper reaches.

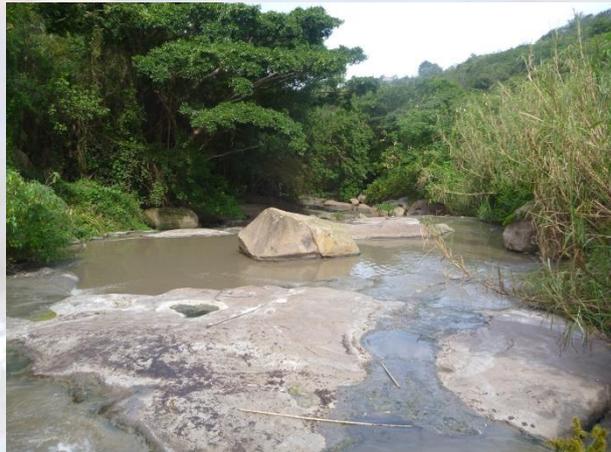
For the 1st three kilometres (waypoints 51 – 36) the river is clear, with 100% clarity. Thereafter until the confluence with the uMngeni River, the water is mostly very grey and cloudy. All turbidity seemed to originate from effluent from surcharging manholes and the outflow of the New Germany Waste Water Treatment Works.

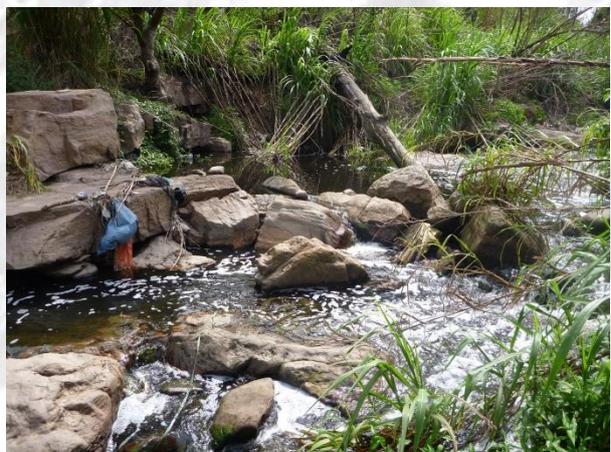
- algae in the river – 1st occurrence in Clermont (waypoint 38);
- high levels of sludge (diatoms) just upstream of the WWTW
- high levels of snails (Physidae or Lymnaeidae spp) at waypoint 22.5
- foam with the appearance of soapsuds (waypoint 27)
- sewage from surcharging sewer manholes

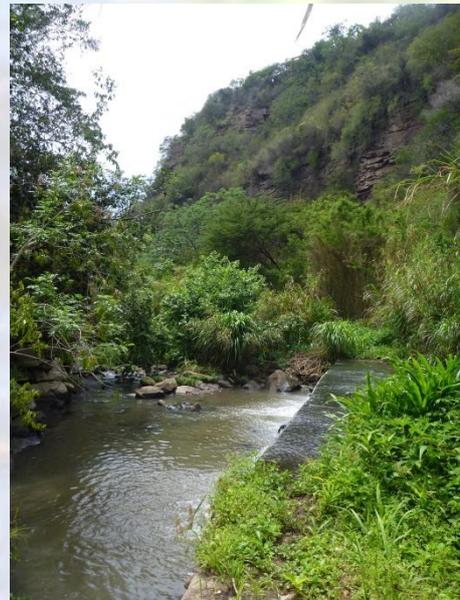
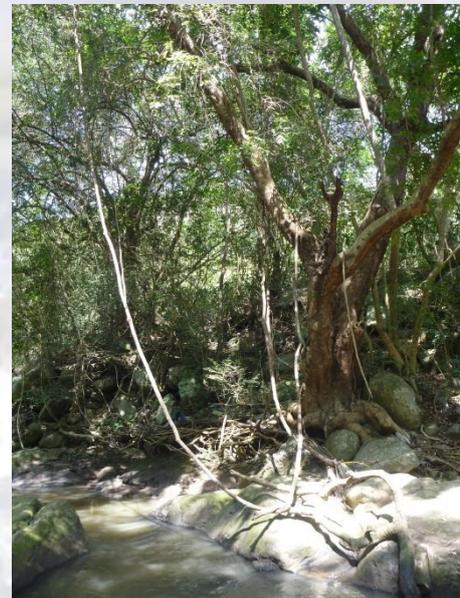
Top: Stone gabion and turbid water from eroded banks, waypoint 43

Upper Middle: Turbid river, waypoint 21
