# Lions River Walk Report

22<sup>nd</sup> to 29<sup>th</sup> September 2013

Compiled by Penny Rees  
Duzi uMngeni Conservation Trust (DUCT)  
March 2014

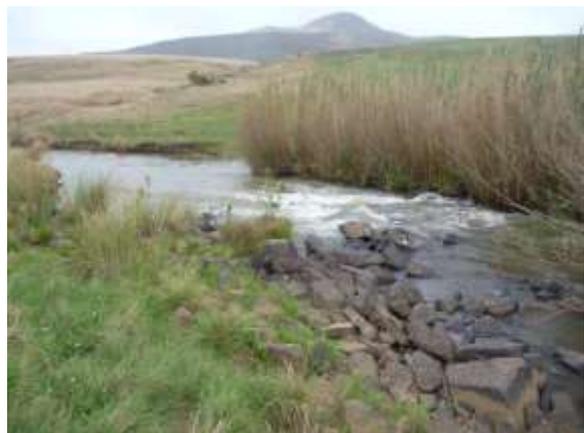
Although this is a rehabilitated wetland, the river banks have an estimated 60 to 70% bramble infestation that stretches back from the river for between 5 to 6 metres in the buffer.

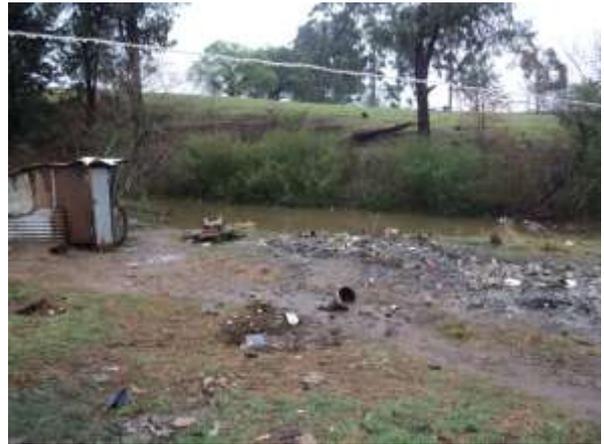
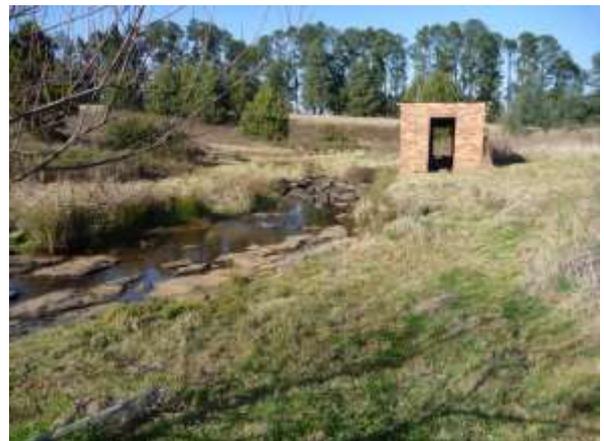
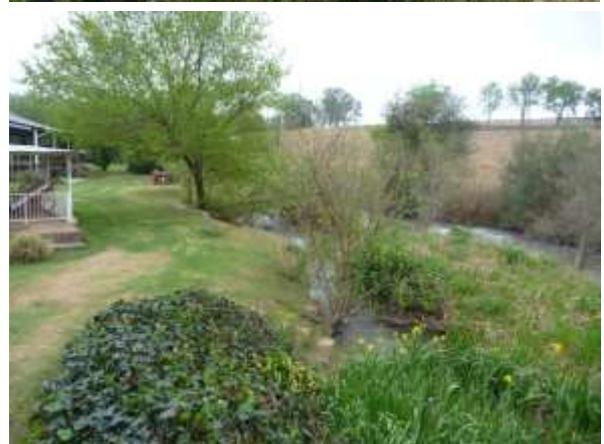
*Top: Historical Dyke*

*Upper middle: Pit toilet on river bank, Lidgetton informal settlement*

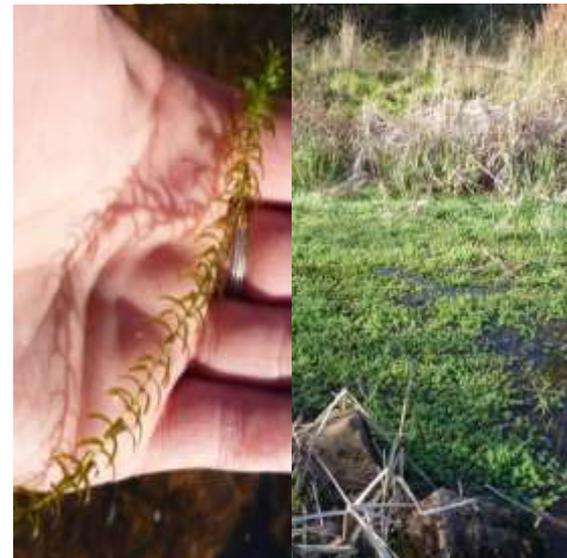
*Top: Possible Potamogeton*

*Upper middle left: Fine Oxygen Weed*

Seen regularly down the Lions was the presence of large quantities of Potamogeton (Pond Weed) and Lagarosiphon muscoides (Fine Oxygen Weed) in the dams, Myriophyllum aquaticum (Parrots Feather), Nasturtium officinale (Water Cress) and bright green patches of algae. Elevated levels of diatoms (were also noted

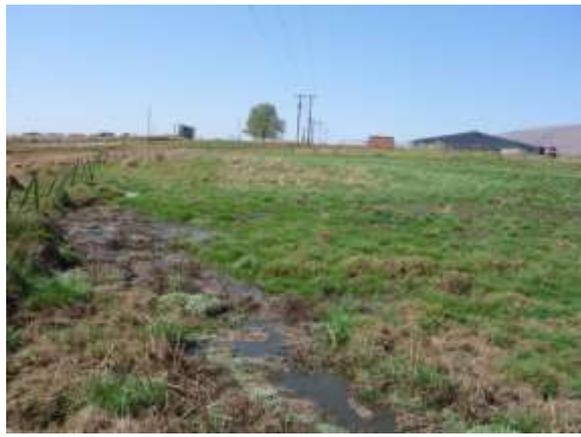
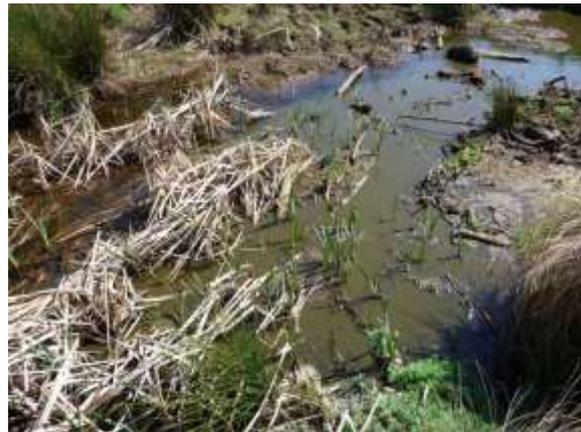
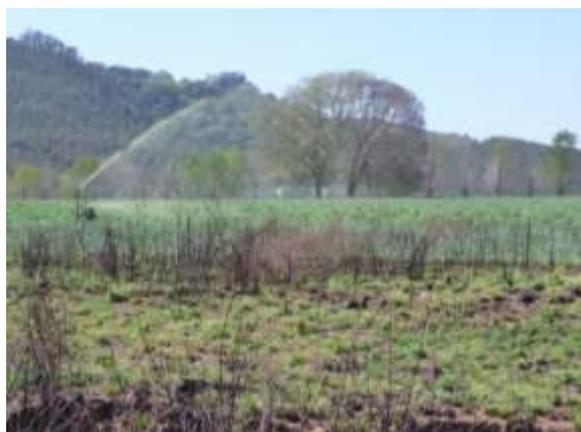
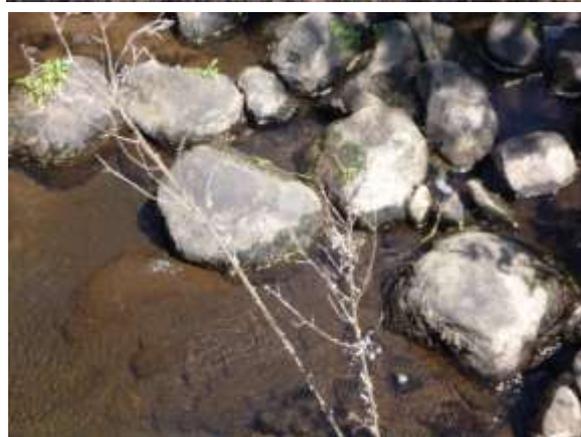
*Top: Dairy slurry leaking down hillside to Lions River*

*Upper middle: Dairy effluent in Lions River*

*Bottom: Fertiliser stains on river rocks*

Liason with Farmers organisations is urgently needed to ensure that all dairy farms have slurry dams that are in good working condition in order to prevent effluent from entering the river.

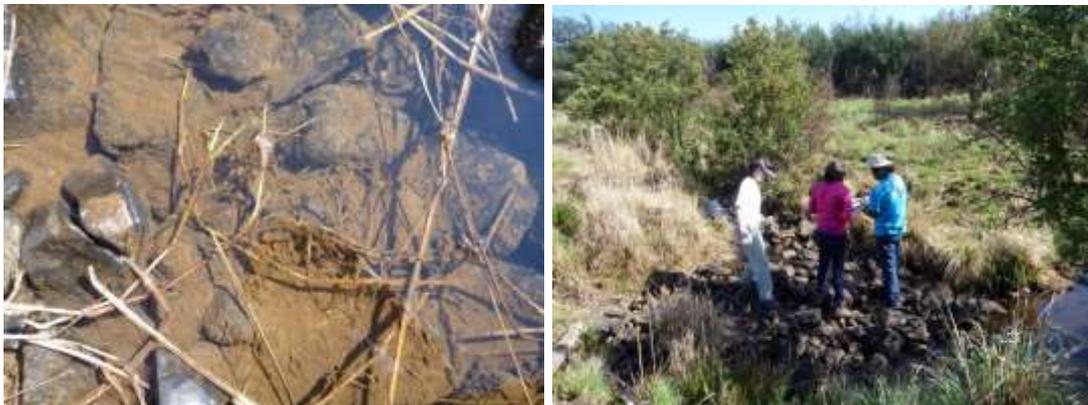
*Mini SASS score:* 4.6 Seriously / critically modified, VERY POOR condition

- Lack of intact riparian buffer - pastures to within 5 metres of the rivers edge and Wattle intruding into buffer
- Elevated levels of nutrients indicated by algae & Oxygen Weed in the dam & Diatoms at test site
- Gulley erosion at dam overflow resulting in elevated silt level in river

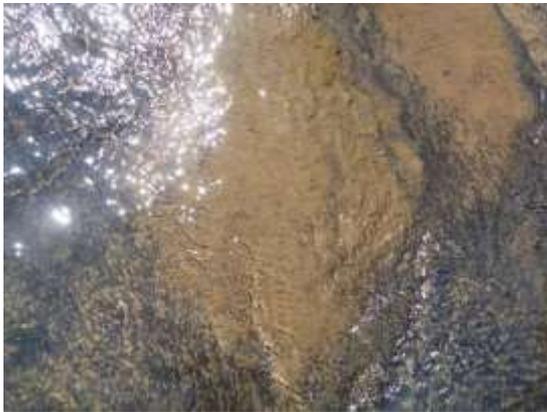
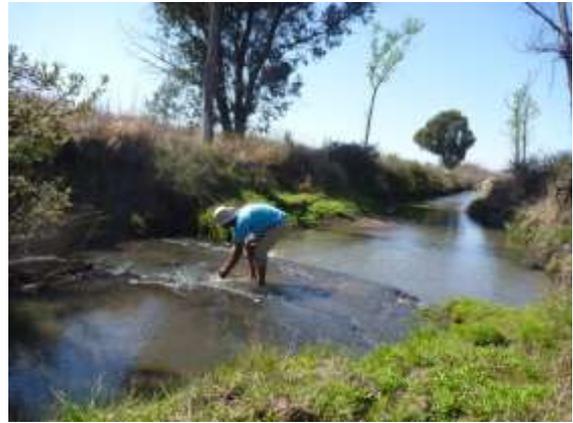
*Mini SASS score:* 5.1 - on the edge of VERY POOR / critically modified and POOR / largely modified condition

*River Health negatively impacted* due to the lack of an intact riparian buffer - ploughed wetland drains, levelled road, kikuyu pastures & bramble.

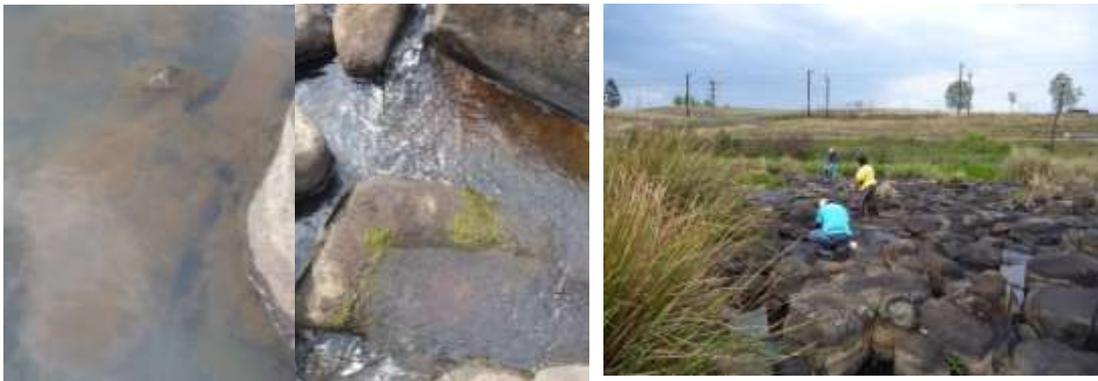
*Mini SASS score:* 5.2 Largely modified, POOR condition

- Low water level in river due to upstream water extraction and dams
- Excess nutrients as indicated by diatoms on rocks and algae in water
- This site is situated downstream of the combined impacts of the intense agriculture along the upper Lions River as well as being at the lower end of the impacts from a 10km stretch which comprises a number of small holdings, timber, a large dairy farm, and two informal settlements.
