Dargle River Walk Report

9th to 12th January 2014

Compiled by Penny Rees
Duzi uMngeni Conservation Trust (DUCT)
February 2015

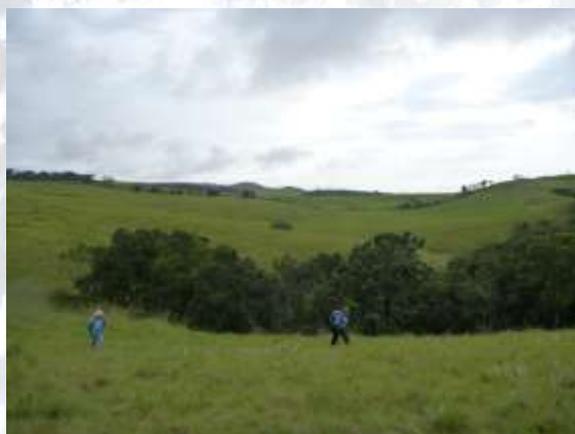
Top: Area 1 - Source grasslands

Area 1

Place: Grasslands around source

Distance from source: 0km

Length: 150 metres

Vegetation: Moist Midlands Mistbelt Grassland

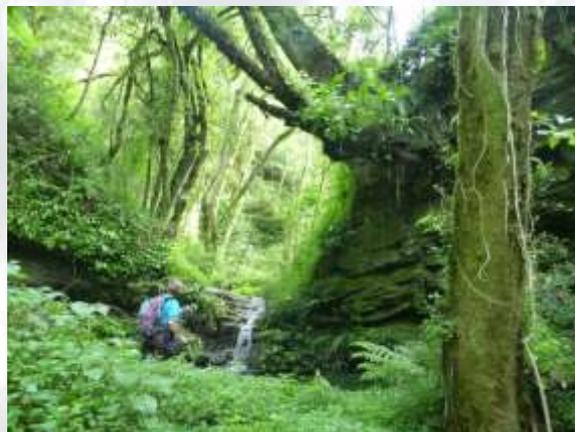
Middle: Area 2 - Source forest

Area 2

Place: Forest below source

Distance from source: 200 metres

Length: 800 metres

Right bank - Indigenous Podocarpus forest for 600 metres

Left bank - Indigenous Podocarpus forest for 800 metres

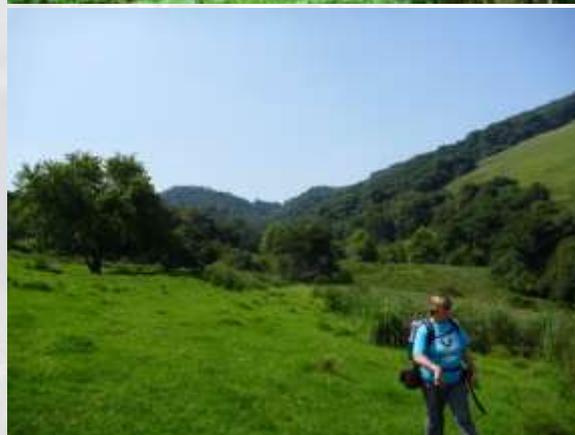
Bottom: Area 3 - Thicket

Area 3

Point: Thicket downstream of forest

Distance from source: +-1.5km

Length: 100m

Vegetation: Thicket of indigenous species

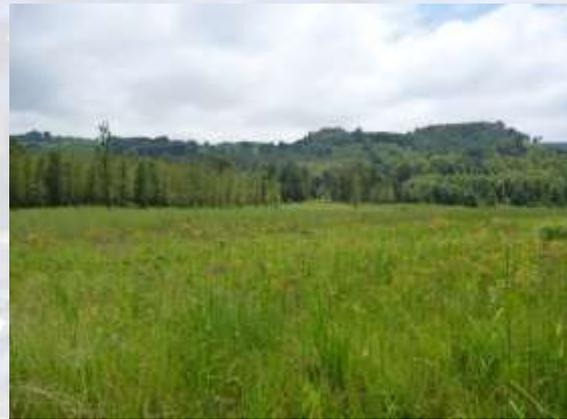
Top: Area 4 - Wetland

Area 4

Point: Wetland upstream of two large earth dams

Distance from source: +-4.5km

Length: 600 metres

Right bank: Wetland with indigenous grassland.

Left bank: Wetland with indigenous grassland and 100 metres of Poplars

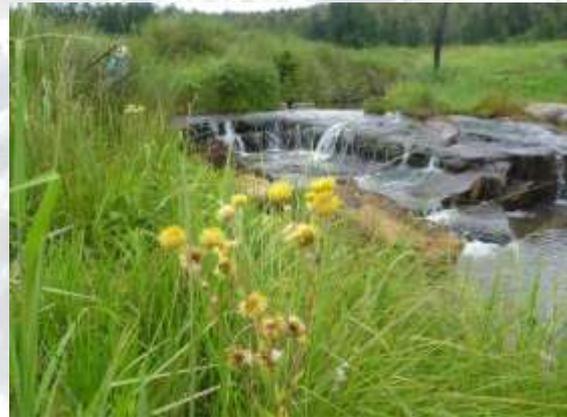
Upper Middle: Area 5 – Upstream of first timber

Area 5

Place: Upstream area of 1st timber plantation

Distance from source: +-5.5km

Length: 600 metres

Vegetation: Indigenous grassland

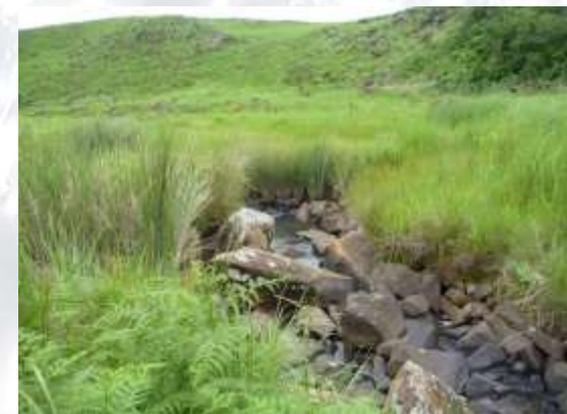
Lower Middle: Area 6 - South of the Dargle road

Area 6

Place: Extending from+-1km south of Dargle / Impendhle road

Distance from source: +-12.5km

Length: +-2.4kilometres

Vegetation: Grasslands and thicket

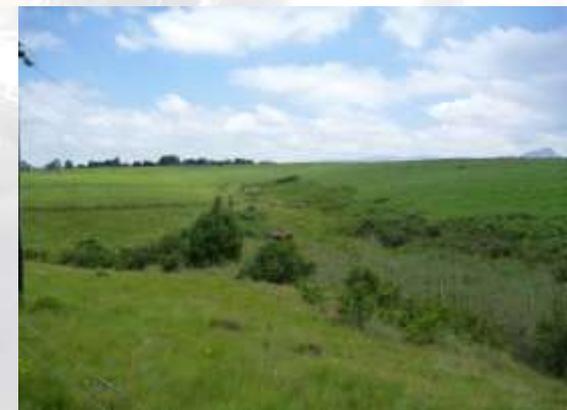
Bottom: Area to be investigated

- An additional area needs to be investigated – the only place where we did not have sight of the river having had to walk on a hill above the river due to the steep bank and almost impenetrable thicket. From what we saw this may be a stretch of +-200 metres length with no invasives. The area is situated between areas 4 and 5 discussed above.

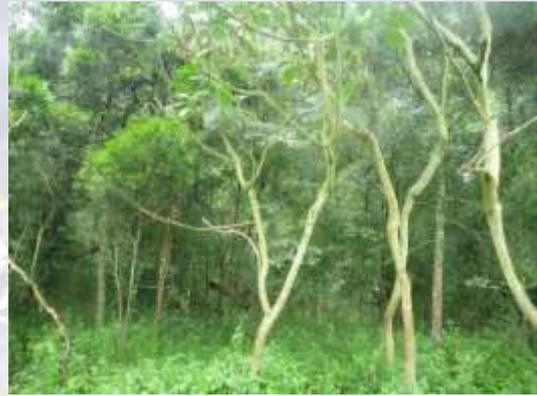
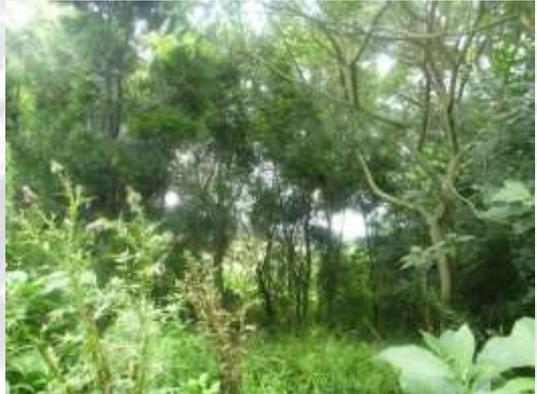
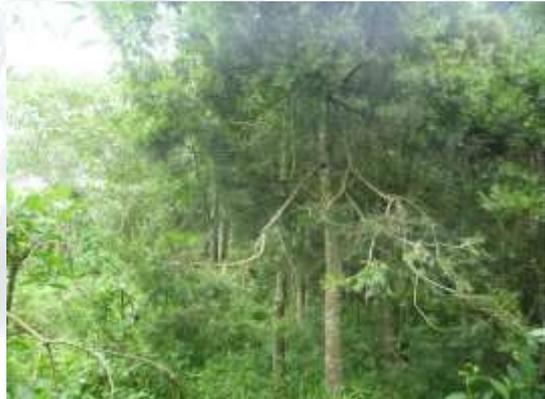
- On one section of the Dargle River an indigenous forest stretches away from the rivers north bank whilst the south bank originally comprised Mistbelt Grasslands. The south bank has been invaded by Bug Weed on a large and dense scale, and many of the Bugweed trees are over 2 metres in height. Thus not only the river is being shaded out by the Bugweed, but also the grassland. This change seems to have created the ideal conditions for Podocarpus (Yellowwood) trees, and there is an area on the south bank approximately 100 metres long that is filled with young Yellowwood Trees growing up amongst the Bugweeds – it is a Yellowwood nursery on a grand, natural scale. The parent trees were visible: a few large Yellowwoods a short distance from the river on the north bank.

What is known as succession is taking place here in an unusual way. Succession refers to the process of vegetative change after an area has been disturbed whereby over many decades the vegetation proceeds through a series of changes from pioneer to climax stage. These changes are known as succession. Pristine grasslands or indigenous forest are examples of areas where the vegetation is in climax stage. Thus the first pioneer plants to appear on disturbed ground are what we generally call weeds, although in reality these are tough, hardy plants that can live in poor soil and are improving and preparing the soil for less hardy plants. The pioneer stage is followed by a succession of other stages until the perfect vegetation mix is achieved for the area and conditions – this is known as the climax stage. The Bugweeds seem to have created the ideal conditions to allow for the Yellowwoods to thrive, and thus perhaps one day, the indigenous forest will cross the river if and when other forest species take root.

Top, Middle & Bottom: Bug Weed and young Yellowwood trees

This should by no means be used as a reason not to clear invasive species in the riparian buffer. Having walked over 200 kilometres of rivers in the Midlands, this is the first time we have seen this happening – up to now such an infestation of Bugweed has been seen to exclude all other vegetation.

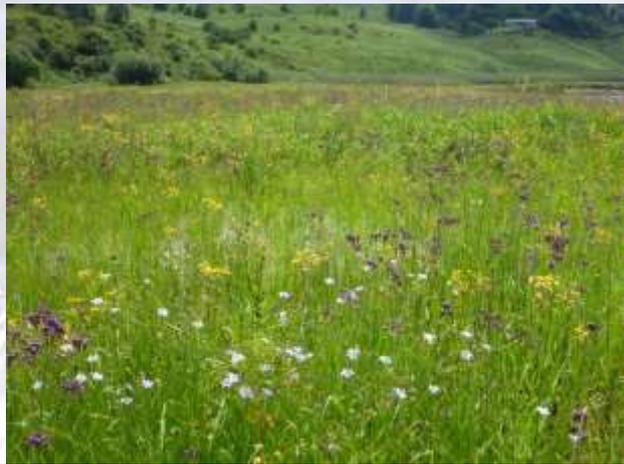
There are three wetlands on the Dargle River. The first lies immediately upstream of an earth dam, and seems to be a remnant of a far larger wetland that was drained historically and is now under pastures and centre pivot. The wetland seems to be in good condition and its riparian buffer on the right bank comprises beautiful grasslands that were dotted with *Wahlenbergia*, *Helichrysum* and other wild flowers, as well as a multitude of birds calling from the reed beds and a Water Mongoose that ran across our path.

Top: First wetland – situated at foot of slope at rear of picture

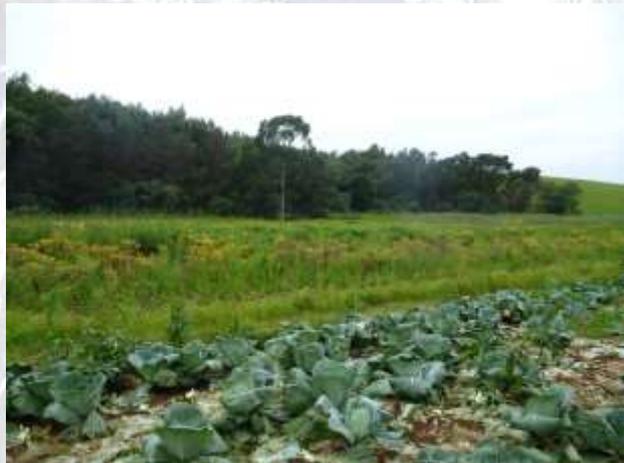
The second wetland lies south of the Dargle / Impendhle road, and seems to be part of a network of long narrow wetlands parallel to each other that alternate with ploughed fields and at least one historical drain. The right bank of the wetland has ploughed lands that intrude +/- 27 metres into the buffer. The left bank is infested with Wattle and Blue Gum trees for approximately half its length.

Middle: Second wetland – situated between cabbage fields and Wattle trees

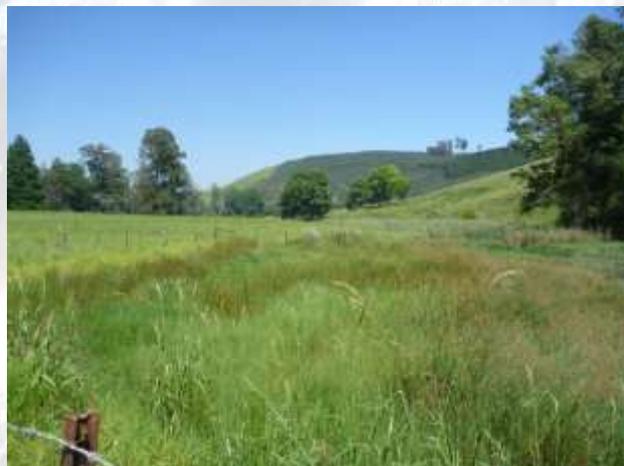
The third wetland is not far from the confluence with the uMngeni River. It lies on a floodplain upstream of a point where a small dam wall was constructed between the narrow, vertical river banks. This wall, which seems to be extremely old, has trapped silt over the decades, and as a result wetland plants have become established forming a wetland that spreads back across the floodplain.

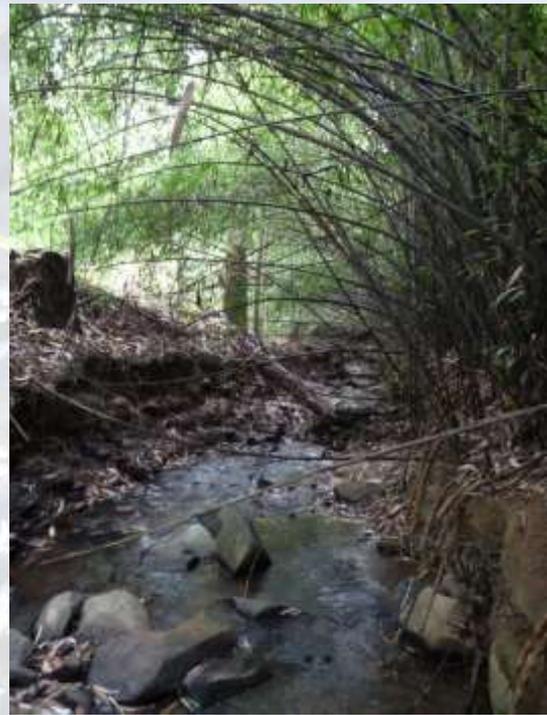
Top: Bamboo infestation in buffer

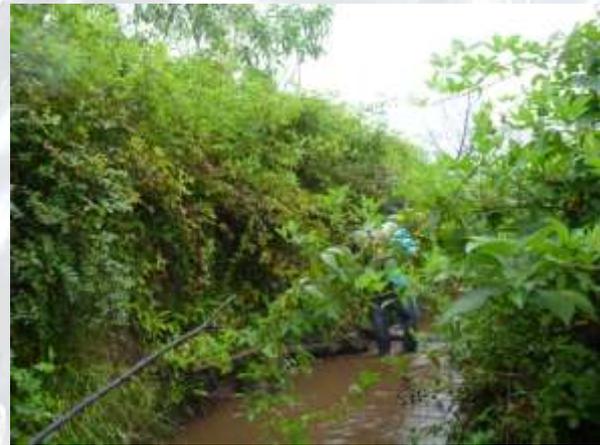
Middle: Bramble infestation in buffer

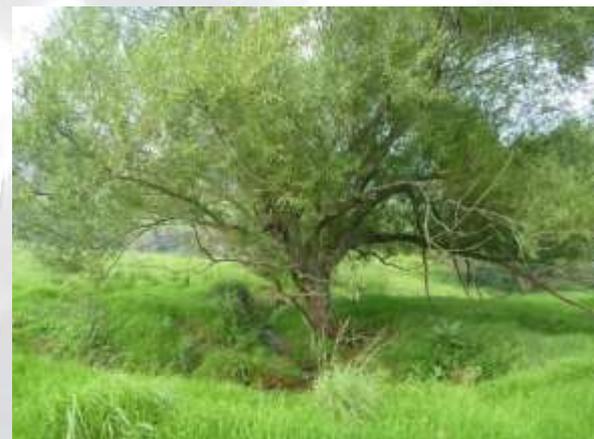
Bottom: Overgrown Kikuyu pastures and Willow tree in river buffer

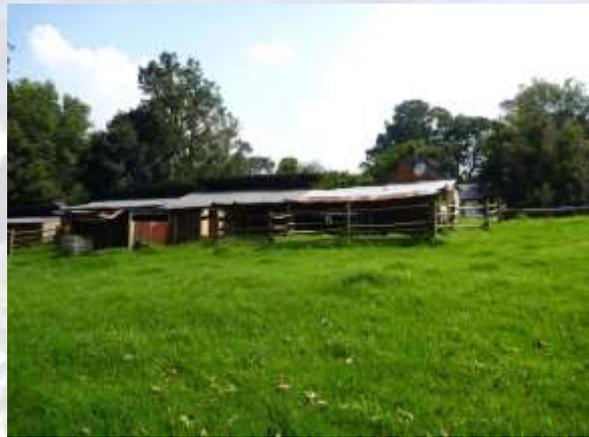
Cattle holding pens within the buffer.

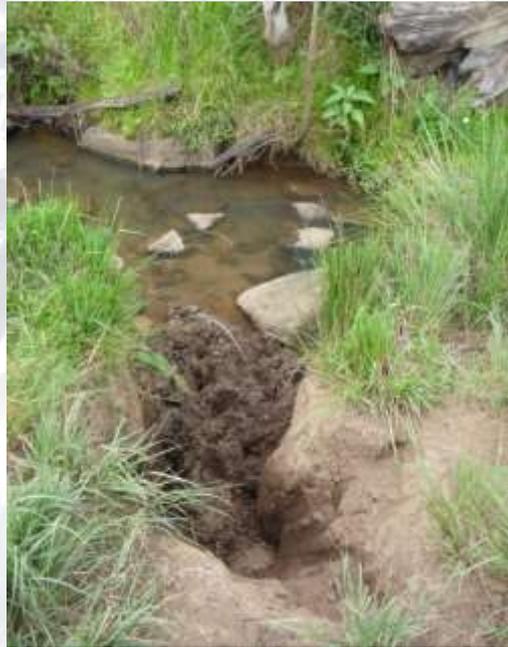
Soil erosion on the river banks results in soil being washed in to the river. Most of the erosion on the Dargle River was localised to nineteen points where cattle have access to the river and their paths have eroded into gulleys. Of the 19 points, five were in a 400 metre stretch of river and twelve were in a 1.3 kilometre stretch of river. The soil was evident as a layer of silt on the river bed at the sites themselves, however it was not apparent beyond +/-30 metres downstream. One other site was eroding where overflows from an off stream dam were running back to the river.

Top: Stock pen and historical Kikuyu pasture in buffer
Middle: Gully erosion caused by livestock accessing river
Bottom: Silt on river bed and rocks

Perhaps landowners could put their thinking caps on and devise ways to prevent this erosion. The following options have either been suggested to us by landowners or observed during our river walks, and most are dependent on a single strand electric fence run along the top edge of the river bank:

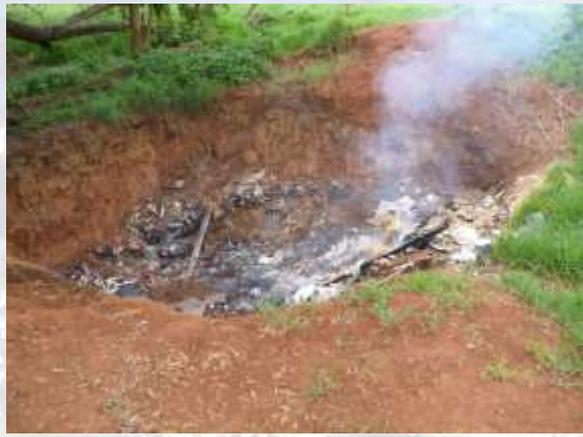
One rubbish pit was recorded on the edge of the buffer.

Top: Rubbish pit on buffer edge

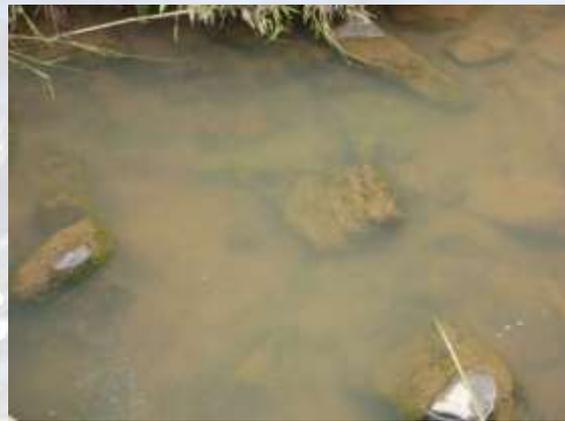
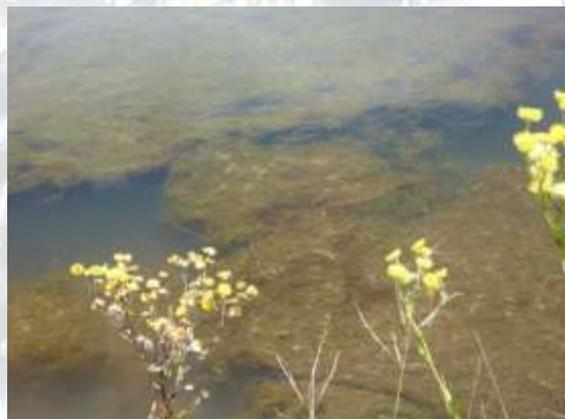
On the Dargle River, signs of nutrification were minimal and extremely localised – elevated levels of Diatoms were observed on a poultry farm and at some of the points where cattle have access to the river. At one place with increased diatoms and algae we were unable to gain any understanding of the source of the nutrients. The following signs of elevated nutrient loads were seen:

Middle: Flourishing unidentified aquatic plants in dam

Bottom: Algae on rocks from unidentified source

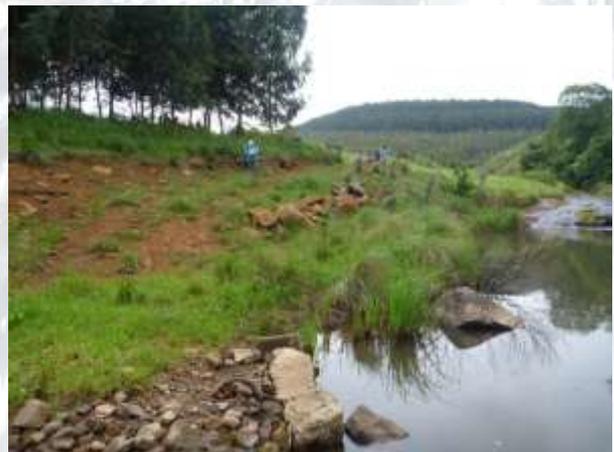
Two causeways were observed, one well built with a large pipe allowing the water to continue to flow, whilst the second was constructed with building rubble and had obstructed the flow of the water and created a pool

Causeway below begonias creating dam effect 804, 805

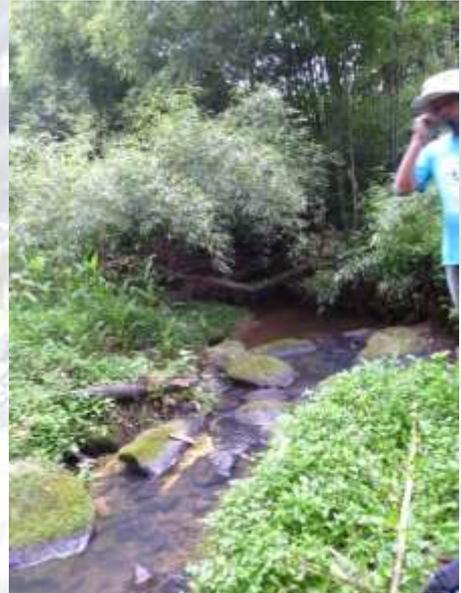
Site 2: Mini SASS

Site description: Approximately 1.5km from source, downstream of cattle pastures

Mini SASS score: 4.75 Seriously / Critically modified, Very Poor condition

- Buffers comprising 100% invasive and alien species including Canna, Firethorn, Bamboo, Periwinkle, Wandering Jew, Wild Ginger

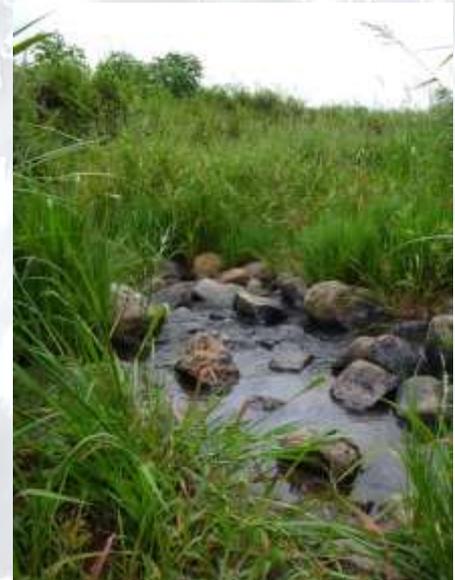
Site 3: Mini SASS

Site description: +-3.5km from source, downstream from arable lands and overgrown kikuyu pastures

Mini SASS score: 4.9 Seriously / critically modified, Very poor condition

- Invasive vegetation in buffer
- Possible contamination from pesticides, herbicides

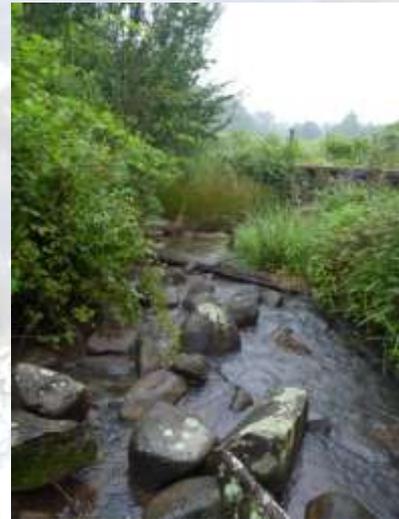
Site 4: Mini SASS

Mini SASS score: 4.71 Seriously / critically modified, Very poor condition

- Heavy infestation of bramble on river banks at site – shading much of the river
 - Kikuyu pastures upstream intrude into the buffer to the rivers edge
 - Bramble in buffer upstream of site
 - Gully erosion from cattle access +-50 metres upstream of site
- Water extraction

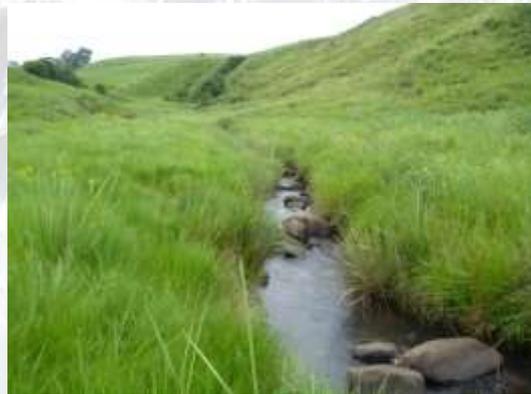
Site 5: Mini SASS

Site description: +-16km from source, downstream of indigenous grassland grazed by cattle on a rotational system

Mini SASS score: 7.5 Largely natural (few modifications), Good condition

River Health is not negatively impacted, as livestock do not have access to the river, the entire buffer zone not only at the test site but for approximately one and a half kilometres upstream is intact and there are no effluent releases.

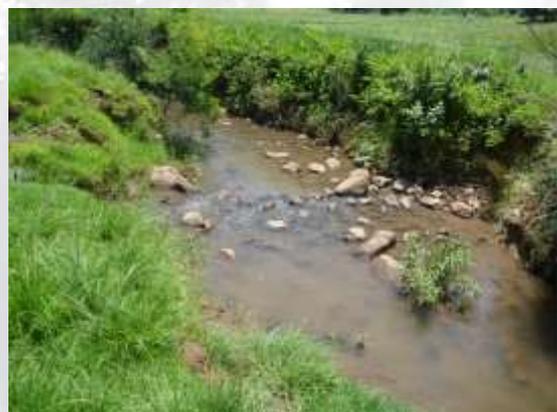
Site 6: Mini SASS

Site description: +-18km from source, downstream of dairy and livestock pastures

Mini SASS score: 5.1 Largely modified, Poor condition

- Lack of indigenous vegetation in buffer areas
- Eroded banks from cattle access to river

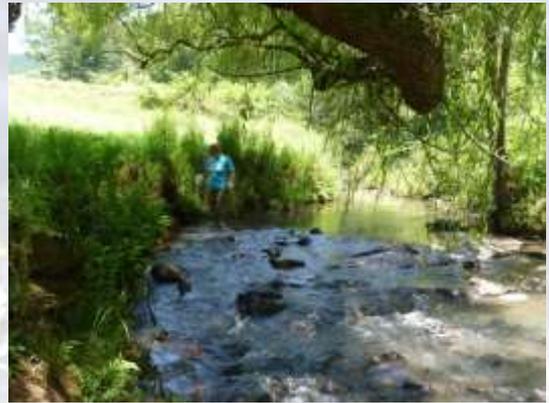
Site 7: Mini SASS

Site description: +-18.5km from source, downstream of dairy, livestock pastures & small wetland

Mini SASS score: 6.6 Moderately modified, Fair condition

- Small dam wall upstream of site (which may, conversely, be preventing silt from moving downstream)
- Kikuyu and other invasives in buffer
