Willowfountain Walk Report

8th to 9th October 2014

Submitted by Sanele Vilakazi
Duzi uMngeni Conservation Trust (DUCT)

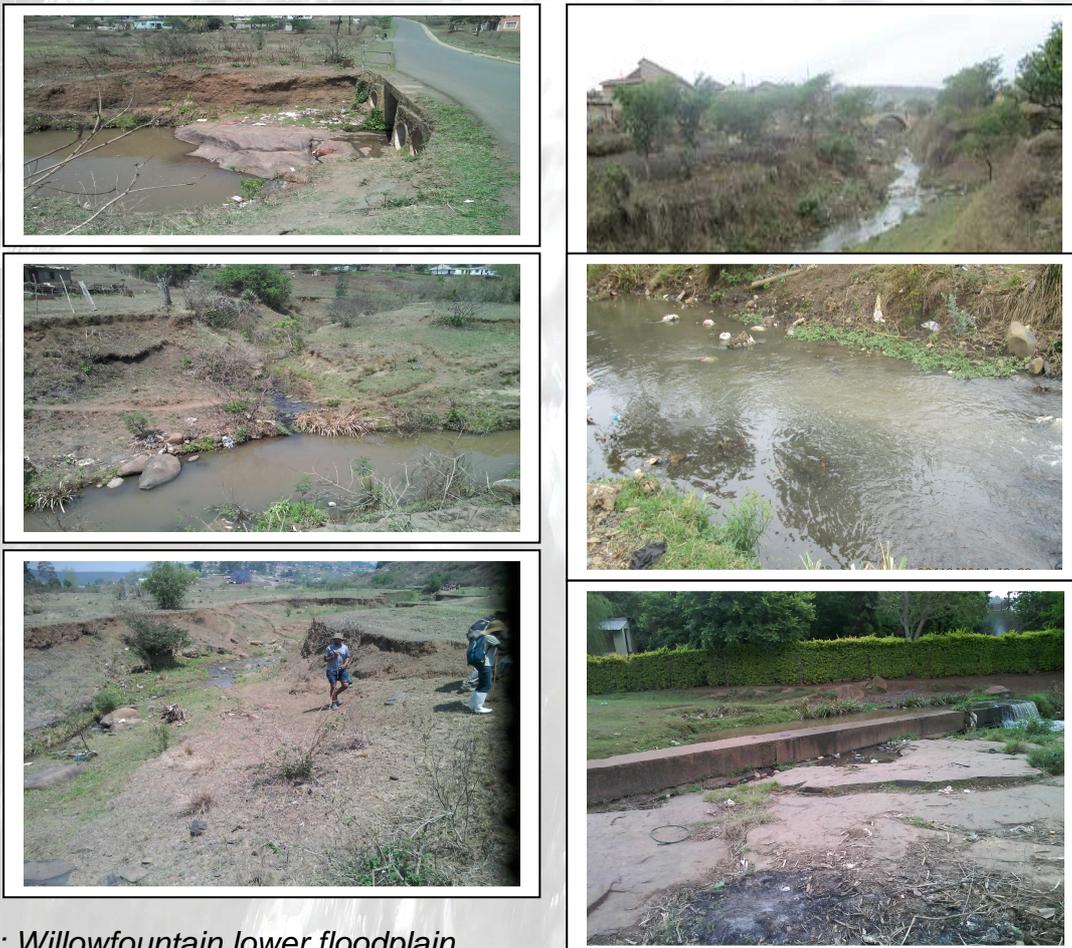
Top: Willowfountain lower floodplain

Lower Middle: Willowfountain sewage effluent contamination

Lower: Willowfountain weir

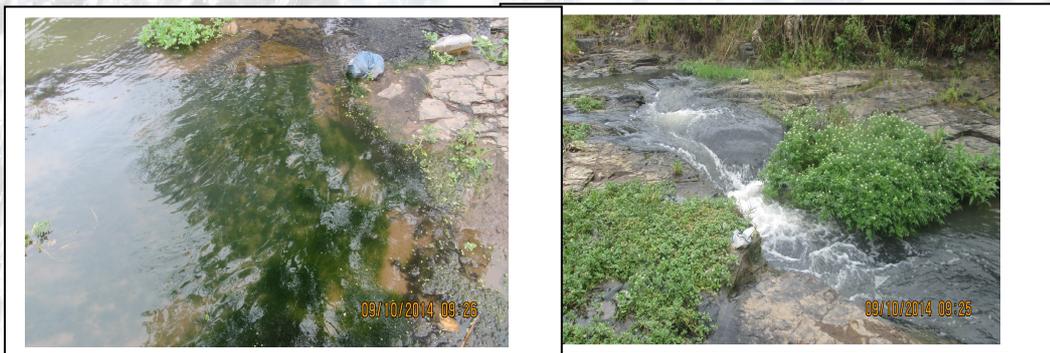
Site 1: Mini SASS

Site description: Approximately 0.4km from source, the region of this river stretch is where the river flows from mountains and into the valley, a sharp reduction in river gradients occur here which has resulted in the deposition of the larger material. The river bed is generally unstable

Turbidity: Water 40% clear

Siltation on river bed and submerged rocks: River bed and some rocks not visible

Mini SASS score: 4.5 Seriously / critically modified, VERY POOR condition

River Health negatively impacted due to:

- Lack of intact riparian buffer - pastures to within 5 metres of the river's edge and alien invasives intruding into buffer
- Elevated levels of nutrients indicated by algae & Oxygen Weed in the river

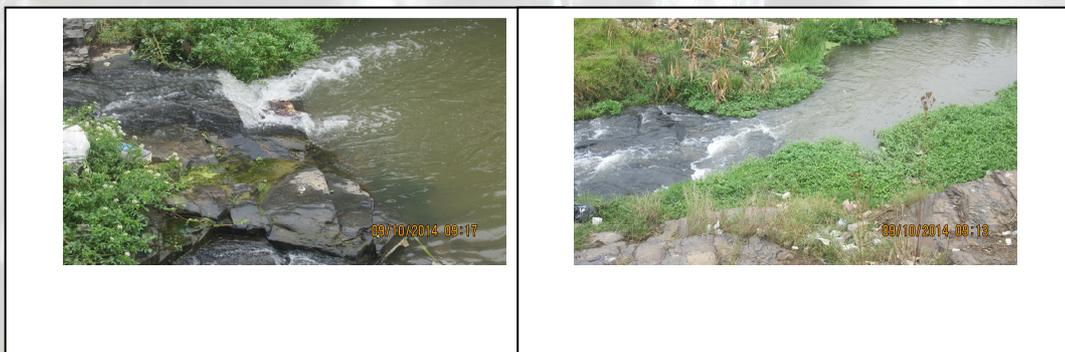
Site 2: Mini SASS

- *Site description:* Approximately 0.5 km from confluence, a shallow part of the channel is found in this region which forms a sinuous shape which can assume various patterns:
Straight and sinuous beds/Meandering beds

Turbidity: Water 25% clear

Siltation on river bed and submerged rocks: River bed and some rocks not visible

Mini SASS score: 4.6 seriously / critically modified, VERY POOR condition

River Health negatively impacted due to: Rubbish dumping

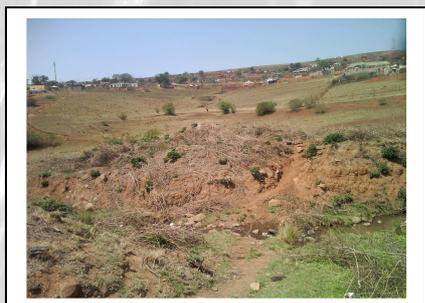
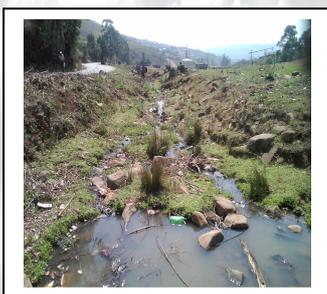
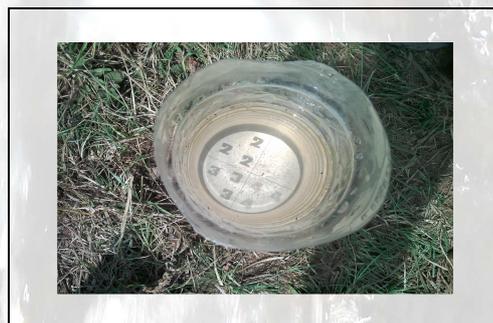
The water was extremely turbid at all times apart from a few of the shallow rocky areas. From the source until the Willowfountain / Slangspruit confluence, the water was 100% turbid.

Some turbidity is caused by silt from “natural” erosion (a direct result of low water levels in the river caused by drained wetlands and heavy extraction) however there were areas where we witnessed effluent causing turbidity (from effluent being disposed of directly into the river; from surcharging sewers spilling over into the river). Turbidity from erosion was soil coloured, whilst the effluent turbidity was a milky grey colour.

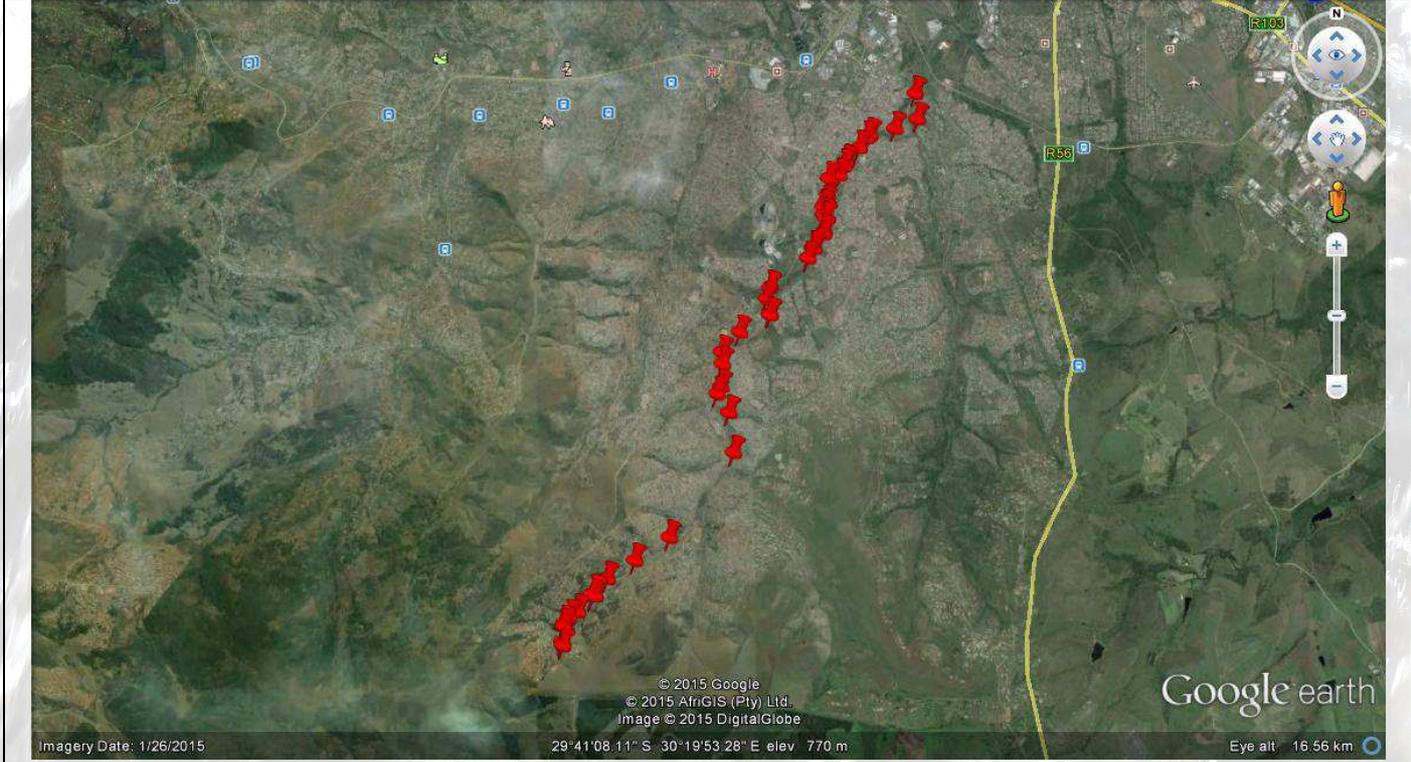
Riverine buffer impact points

Many residential areas/establishments neighbouring the Willowfountain do not respect/obey the 32 metres buffer, either by constructing buildings, erecting fences/walls, informal settlements, gardens, lawns and uncontrolled invasive plants. From our observations the river water was found to have great excess nutrients from various types of urban/industrial effluent. This was clearly evident from the change in water colour of the river itself. Some stretches of the river were found to be algae green robbing the waters of the Willowfountain of oxygen. However, it is not all doom and gloom for the Willowfountain. With implementing the correct evasive/control action, large stretches of the Willowfountain can be healed.

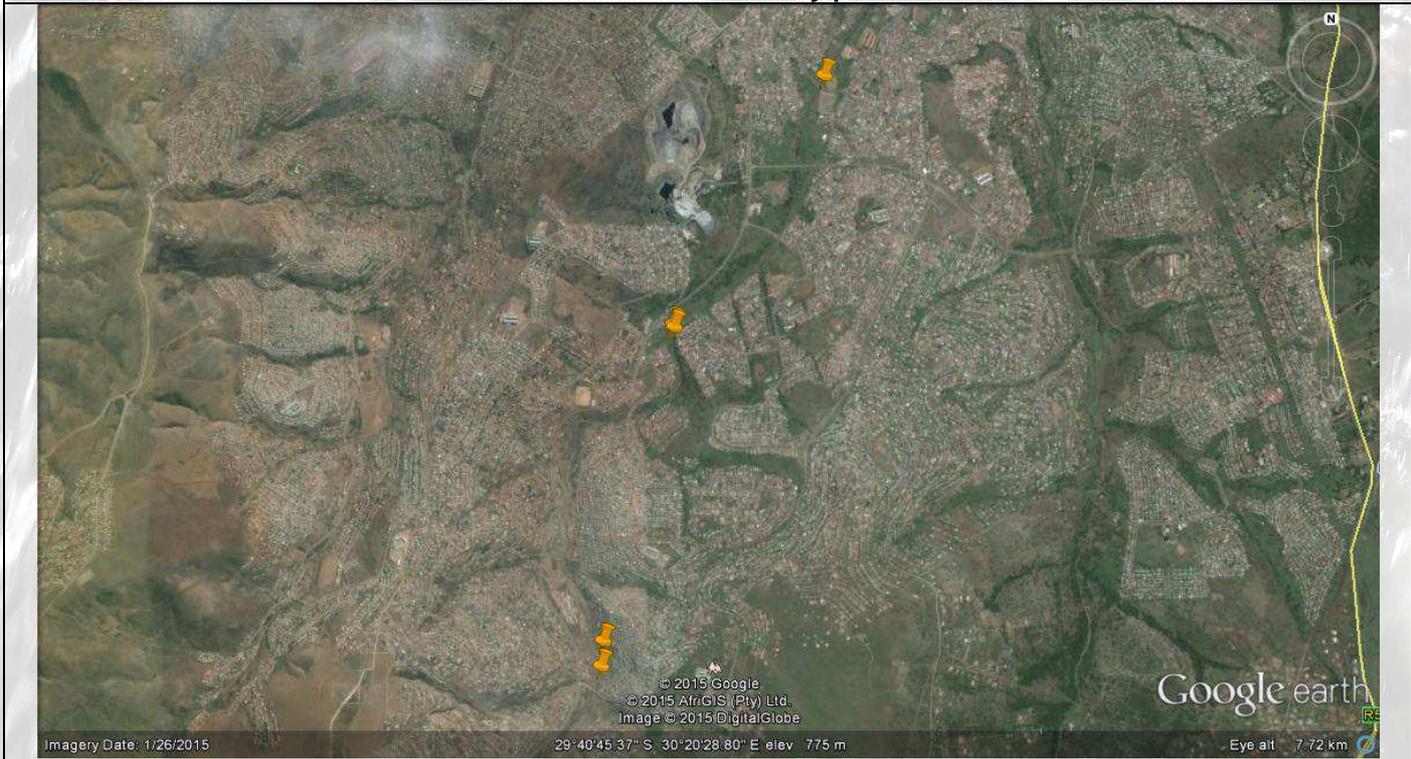
Sewer effluent points

- *Effluent/Sewerage*
 - Surcharging manholes are a common site along the entire length of the river channel resulting in effluent/sewerage flowing directly into the river
 - Cattle access to the river cause additional nutrients from faeces
