# Mpofana River Walk Report

23rd to 25<sup>th</sup> September 2014

Compiled by Penny Rees  
Duzi uMngeni Conservation Trust  
(DUCT)  
February 2015

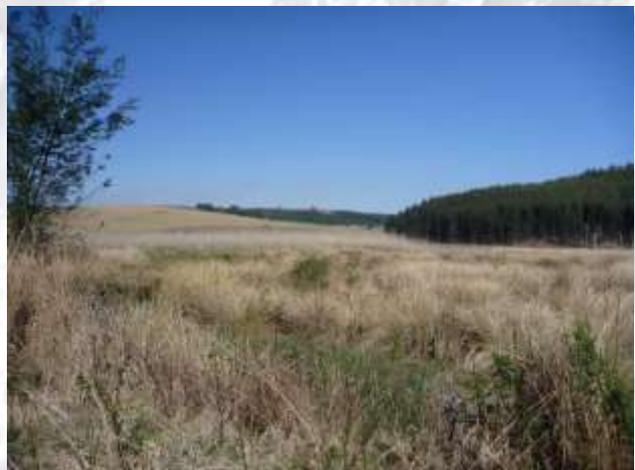
*Middle: Zenzanani Wetland - construction road for Springgrove transfer pipe bisecting wetland*

*Wetland adjacent to Zenzanani Village:* crossed by a a rock “causeway” road (pipeline servitude)

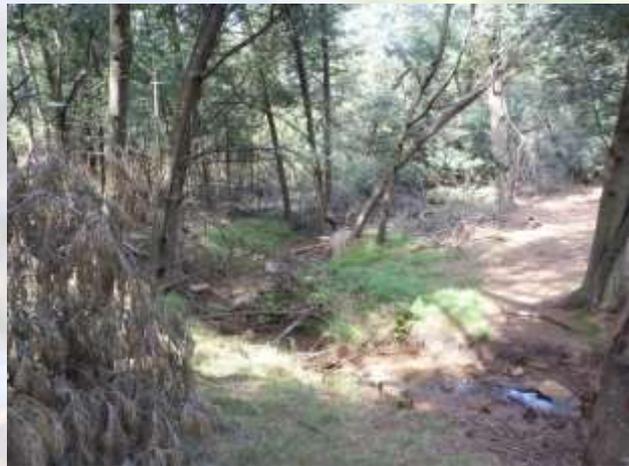
*Top: Reduced stream flow*

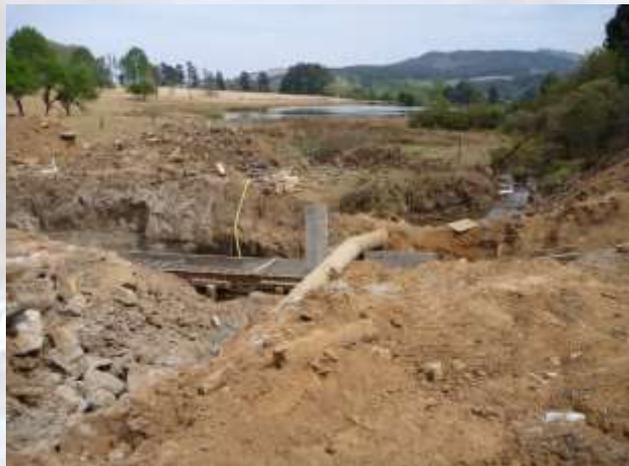
*Upper Middle: Pipeline construction*

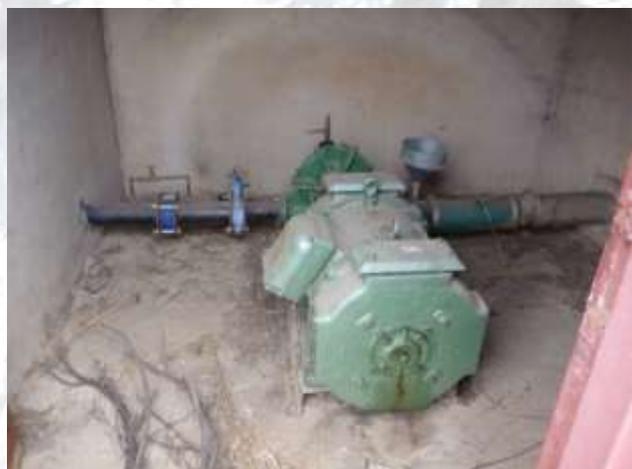
*Lower Centre: Extraction pump*

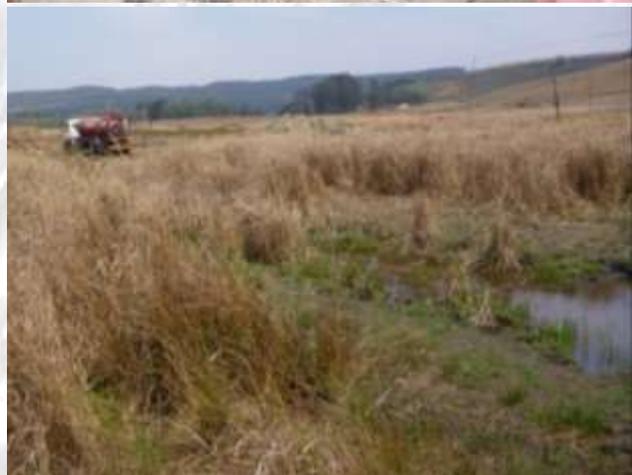
*Bottom: Extraction from wetland*

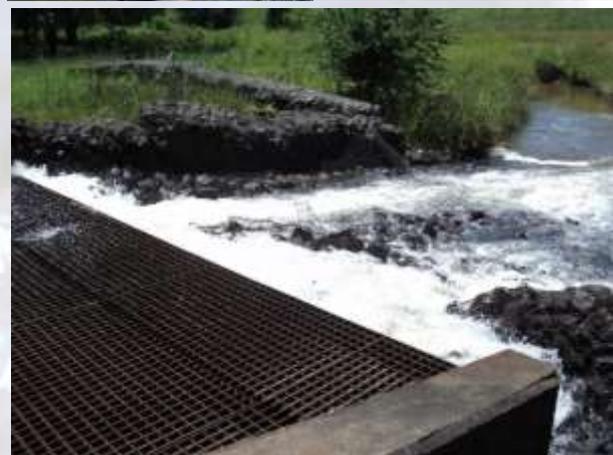
*Top: (left) Turbid water downstream of outfall; (right) clear water upstream of outfall*

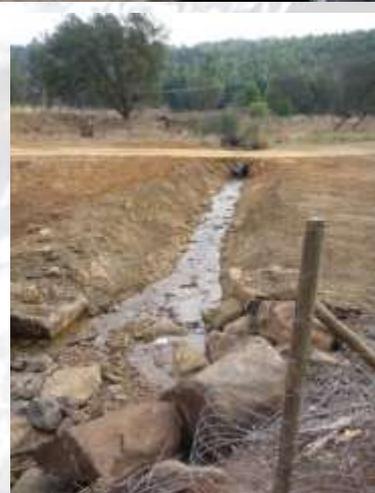
*Upper Middle: MMTS outfall point*

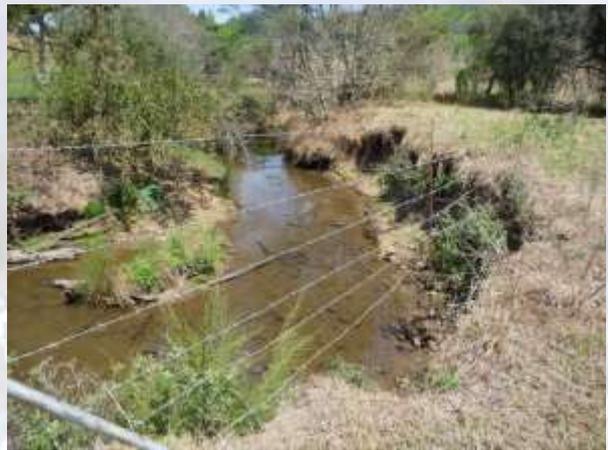
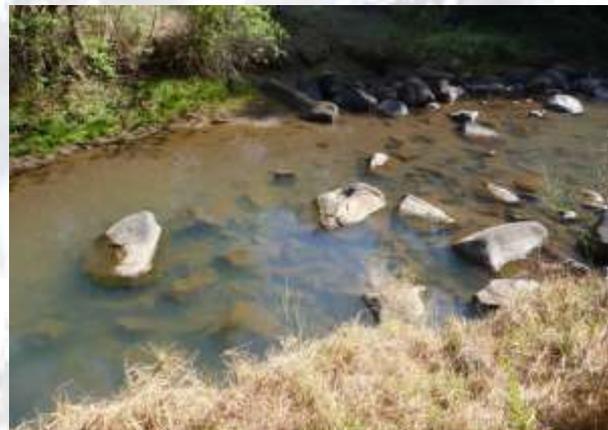
There is no doubt in our minds that the erosion of the Mpopfana banks has been accelerated by the waters of the transfer scheme.

*Top: Eroded banks downstream of outfall  
Upper Middle: Fence over eroded bank  
Lower Middle: Typical silted river downstream of outfall  
Bottom: Typical clear water upstream of outfall*

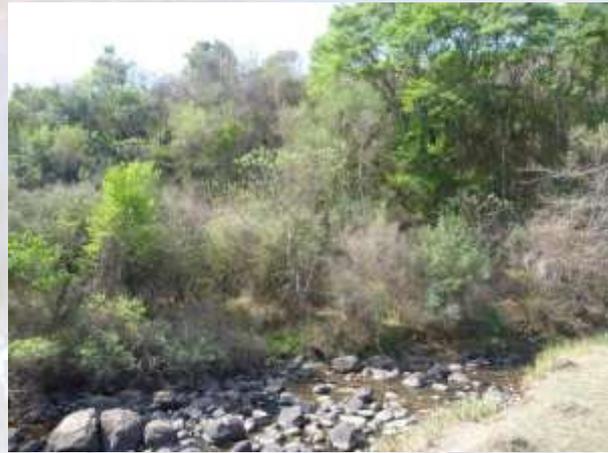
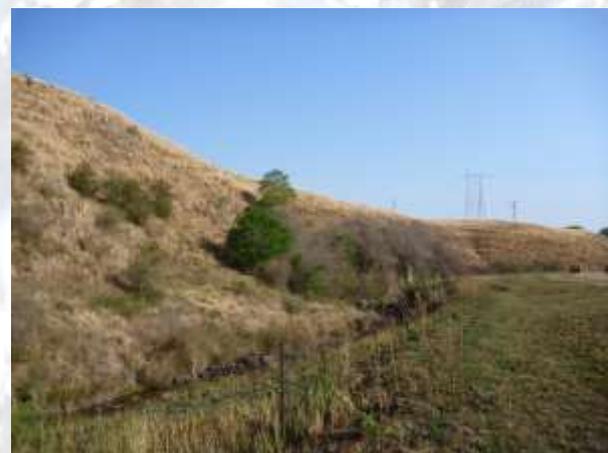
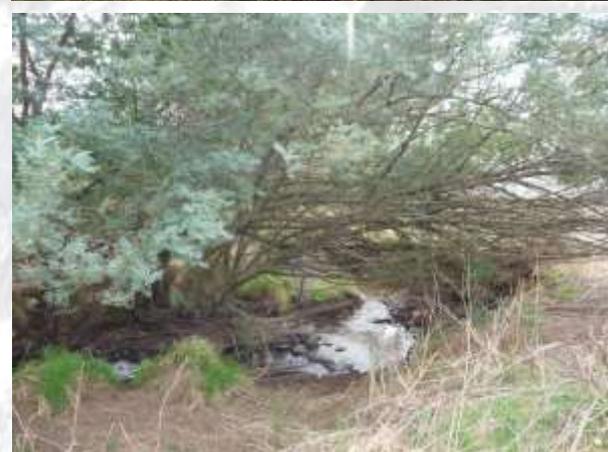
*Top: Invasive Pickerel Weed*

*Upper Middle: Buffer (natural), with indigenous vegetation and stable river banks*

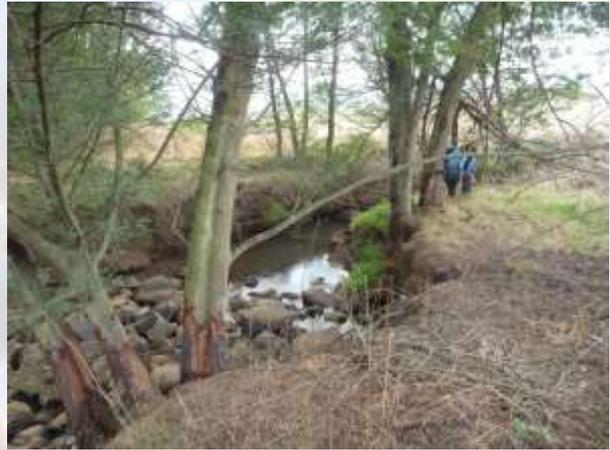
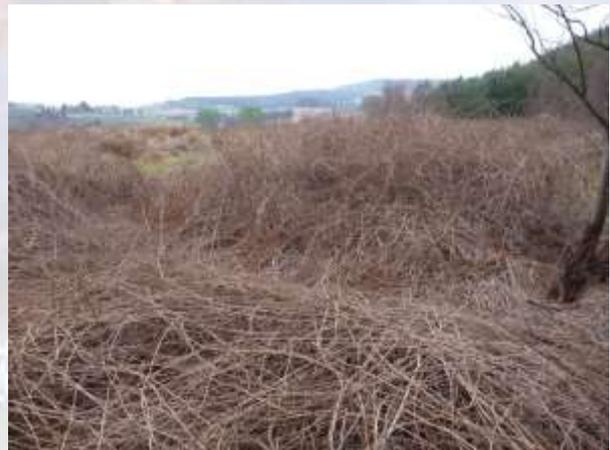
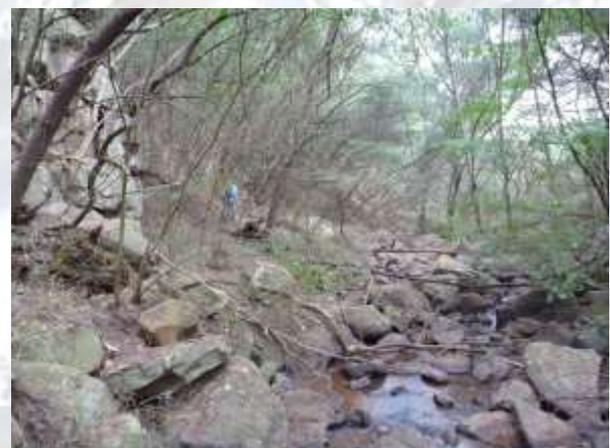
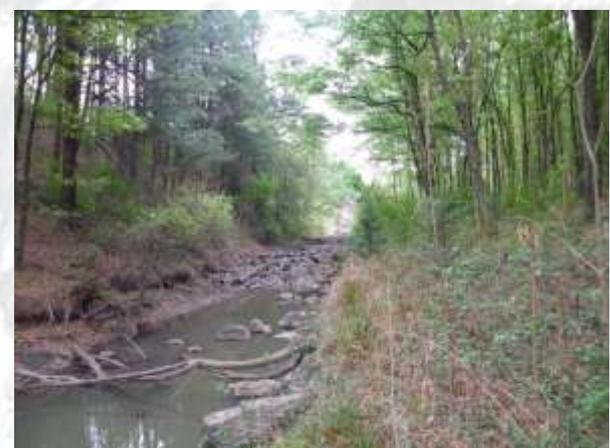
*Top: Ring barked Wattle*  
*Upper Middle: Treated Bramble*  
*Lower Middle: Self seeded Wattle in buffer*  
*Bottom: Saw Tooth Oak planted in buffer*

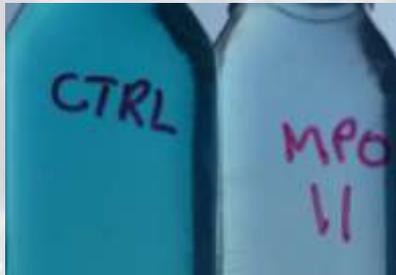
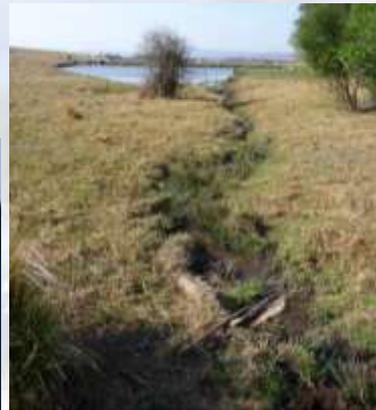
Excessively high nutrient loads in the Mpopana due to cattle accessibility to the dam and stream, at which times their faeces are creating the over nutrification problems.

The tell-tale algal bloom observed in the water is additional evidence of the over nutrification.

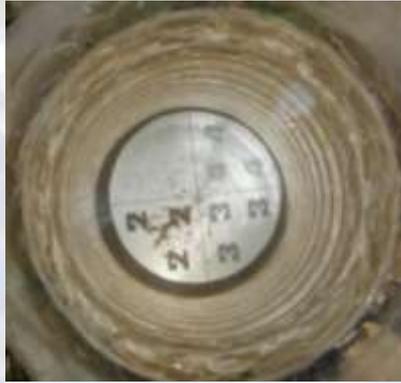
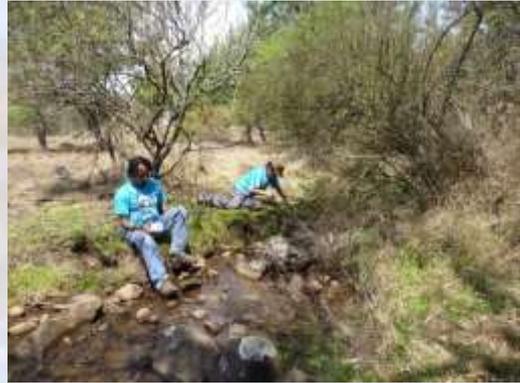
### Site 2: Mini SASS

*Mini SASS Score:* 6.3 Moderately modified, fair condition

- Upstream ring barking of large invasive wattle trees as well as clearing of smaller wattle trees allowing regeneration of indigenous grasses and sunlight penetration
- Regeneration of indigenous vegetation for +-200 metres along the buffer
- Approximately 50% of the buffer comprising indigenous vegetation

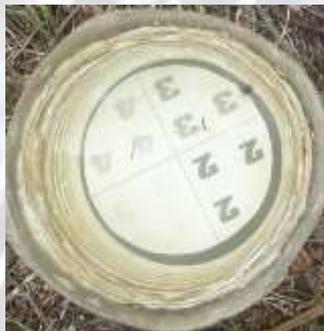
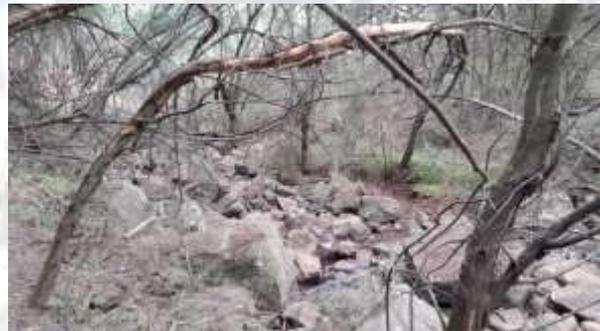
### Site 3: Mini SASS & Meth Blue

*Mini SASS Score:* 6 Largely Modified, poor condition

- Upstream dam not releasing sufficient water
- 95% of river buffer up to waters edge under wattle with 5% bugweed
- Light concentration of siltation on river bed & rocks as well as detritus from wattles (leaves, bark etc) which changes the [pH (acidity) of the water

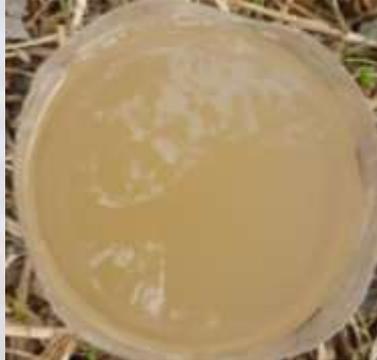
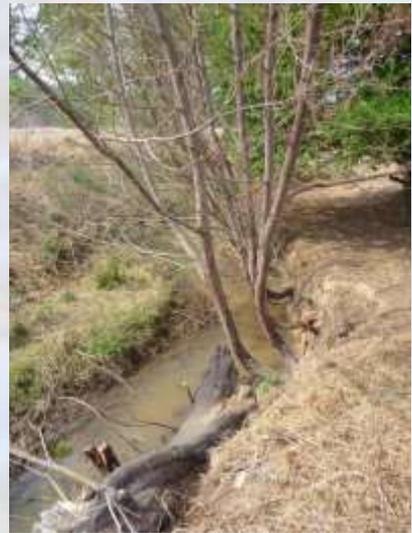
- Low level bridge forming small cascade which is eroding downstream side of the bridge
- Large quarry adjacent to road +/-700m uphill of river
- Intense cattle and sheep trampling of river banks
- Road in buffer zone (+/-5metres from river bank)

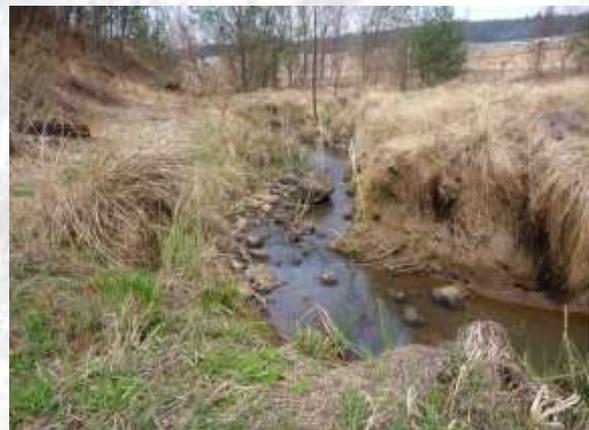
### Site 5: Mini SASS

*Mini SASS Score:* 7.1 - Largely Natural / few modification GOOD condition

- Intact riparian vegetation in buffer on right bank (wetland and grassland)
- Intact grassland for +/-10 metres of left bank buffer
- Wattle clearing in buffer and beyond on left bank for +/-100m length

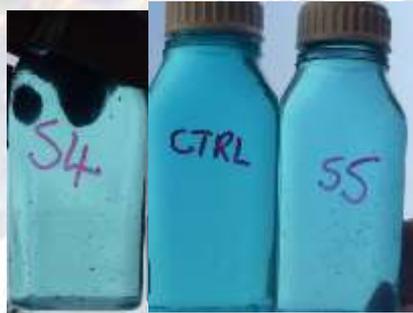
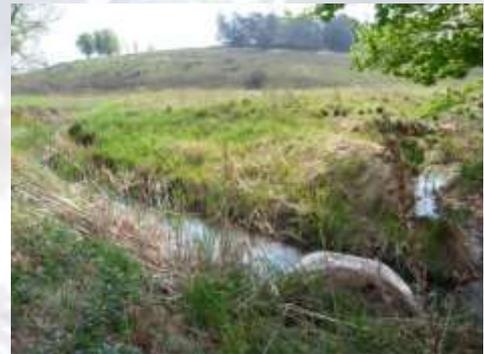
### Site 6: Meth Blue (2 samples)

- Left bank slightly upstream comprises indigenous grassland

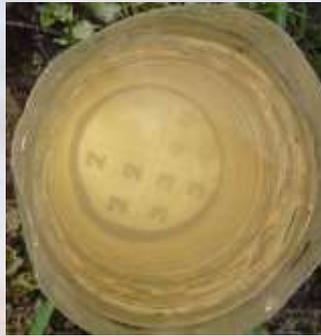
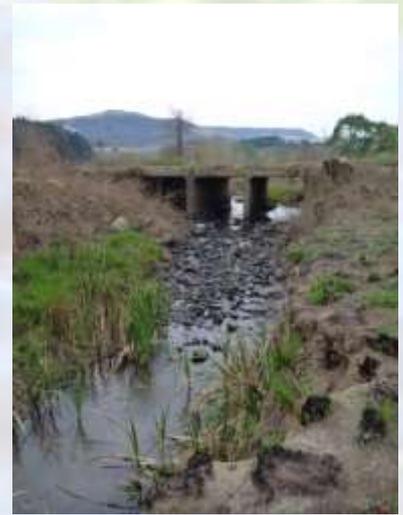
### Site 7: Mini SASS

*Mini SASS Score:* 6.3 Moderately Modified, Fair condition

- Intact riparian buffer
- Intact floodplain beyond buffer

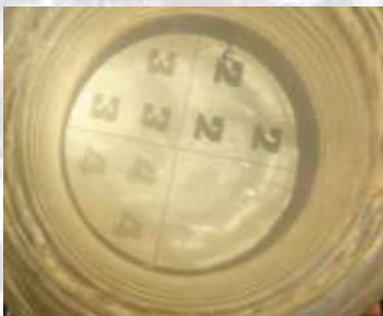
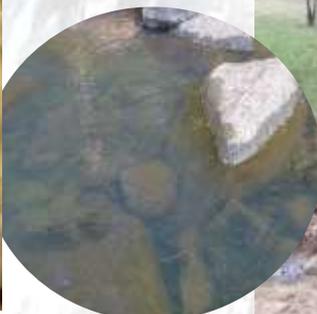
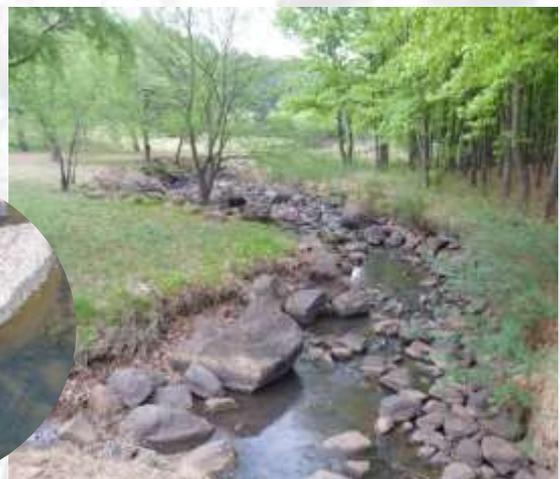
*Mini SASS Score:* 6.3 Moderately Modified, Fair Condition

*River Health negatively impacted* due to:

- Immediately upstream of the test site for approximately half a kilometre is timber planted to the river edge on both banks, followed by timber on the left bank and lawn planted to the rivers edge on the right bank.
- Siltation on river bed for the first time at unacceptably high levels, such that many pebbles are invisible under the silt layer. As this is the first test site downstream of the MMTS outfall, and is only +- 1 kilometre from the outfall, we attribute the silt to a combination of the scouring, eroding impact of the outfall combined with the naturally sedimented incised channel downstream of the outfall.

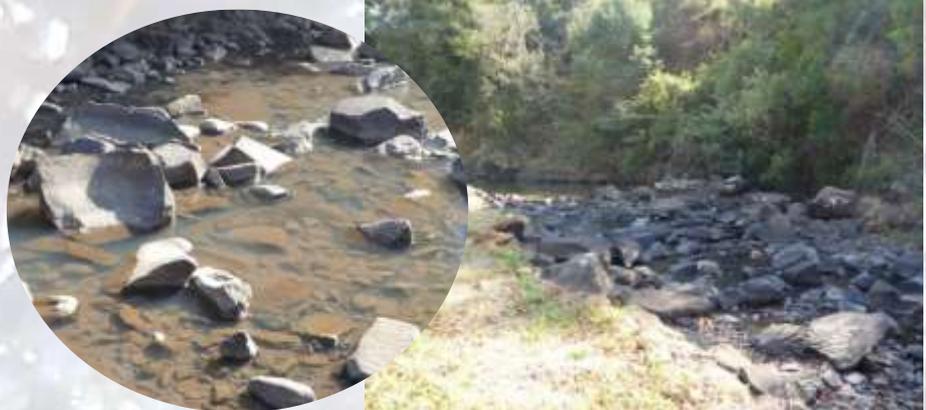
### Site 9: Mini SASS

*Mini SASS Score:* 5.9 Largely Modified, Poor Condition

- Major earthworks on river bank less than 1km upstream of test site
- Rock causeway obstructing water flow +/- 200 metres upstream of test site
- Timber into buffer less than 200 metres upstream of test site and
- Lawn to rivers edge at test site

- Left bank buffer and beyond is indigenous bush for almost 1km upstream

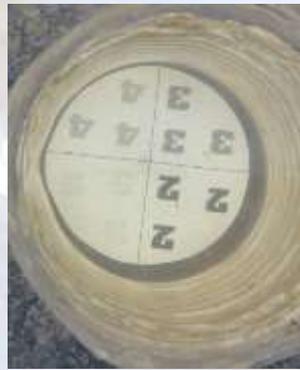
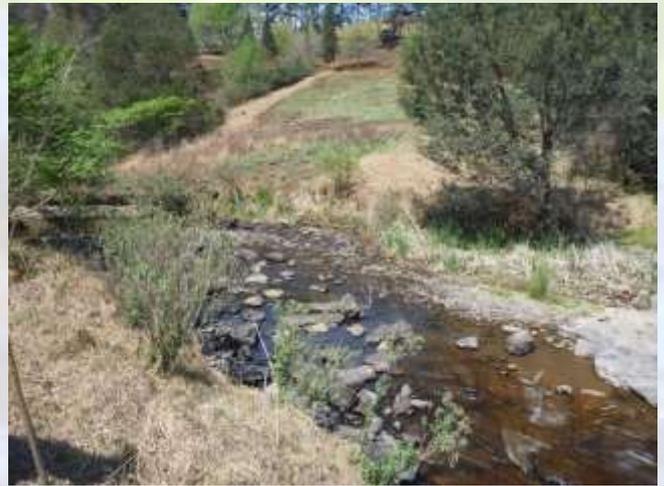
### Site 10: Mini SASS

*Mini SASS Score:* 6.2 Moderately modified Fair condition

A Mini SASS conducted in May 2014 during a Balgowan Conservancy Water Workshop produced a score indicating Natural / Unmodified condition

- Invasive clearing on left bank has allowed for indigenous vegetation to recover

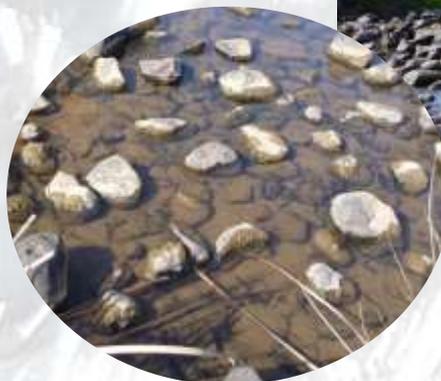
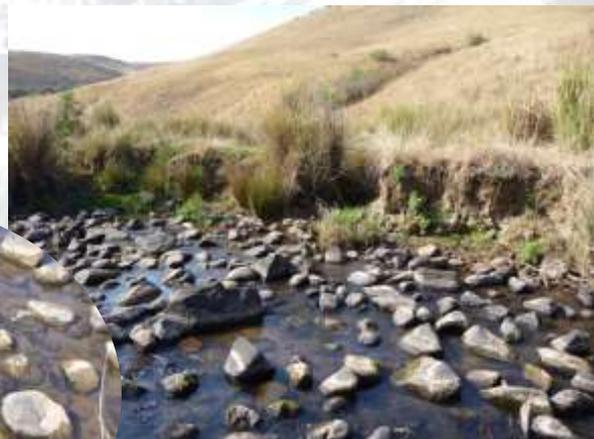
**Site 11: Mini SASS**

*Mini SASS Score:* 5.4 Largely modified, Poor Condition

- All invasive plants have been removed for a distance of 1.5km upstream of the site, creating an uninterrupted, intact buffer on both banks of the river for +-1.5 km upstream of site and continuing downstream of the site for 1.2 km on the left bank and a couple of hundred metres on the right bank
