Aller River Walk Report

6th & 7th November 2015

Compiled by Penny Rees
Duzi uMngeni Conservation Trust (DUCT)
December 2015

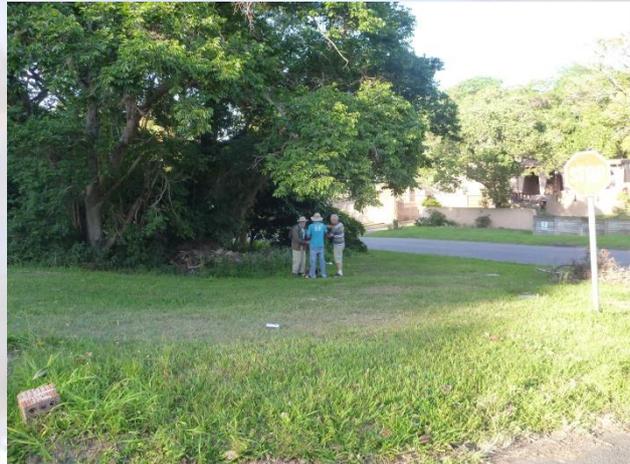
Top: Source area of the Aller

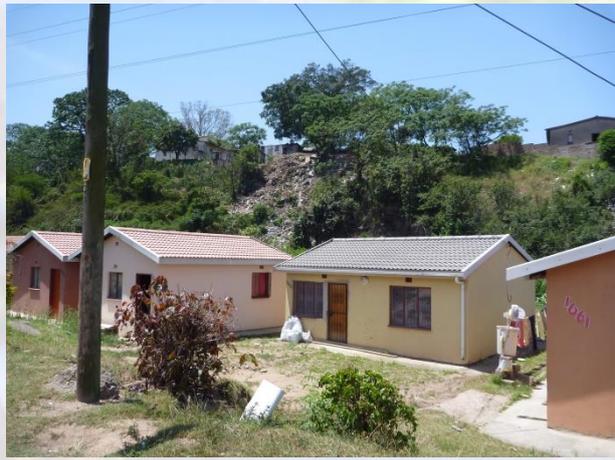
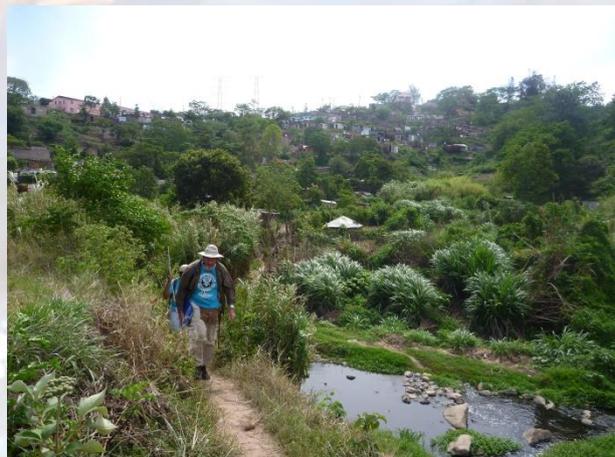
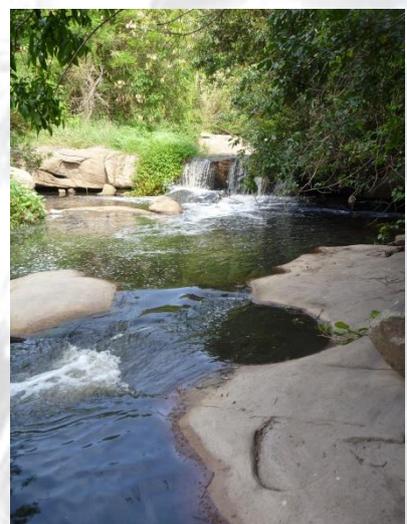
Lower Middle: Sewage in the lower reaches of the Aller

Bottom: Clear, snail infested cascade area

Not 400 metres downstream a sewer manhole is surcharging, pouring raw sewage into the Aller River and turning the clear water into a grey mess. Having thus far run in a general west to east west direction, the Aller now begins to run in a north-easterly direction, the river rapidly descending and the steep sides of the valley rising up a hundred metres above the river in places. The banks are clothed in thick Valley Bushveld species as the Aller cascades and rushes in tight bends downwards to the uMngeni River flowing for approximately six kilometres through a largely wild and untouched valley of interlocking spurs, where the cliffs echo with bird calls, and the only riparian impacts seem to be ten old causeways, six water pipes crossing the valley bottom, the ever present sewage manholes and a rough largely disused vehicle track running alongside the river.

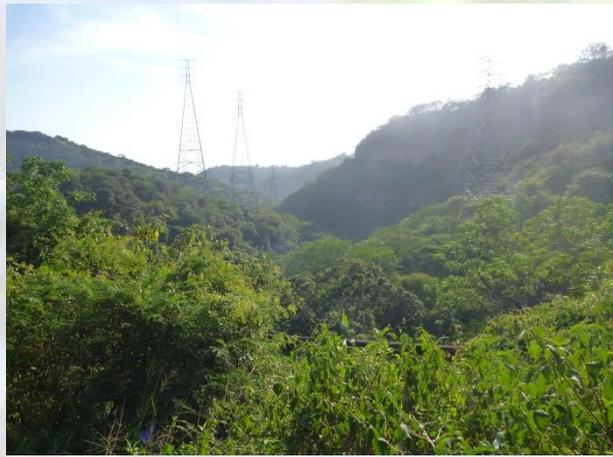
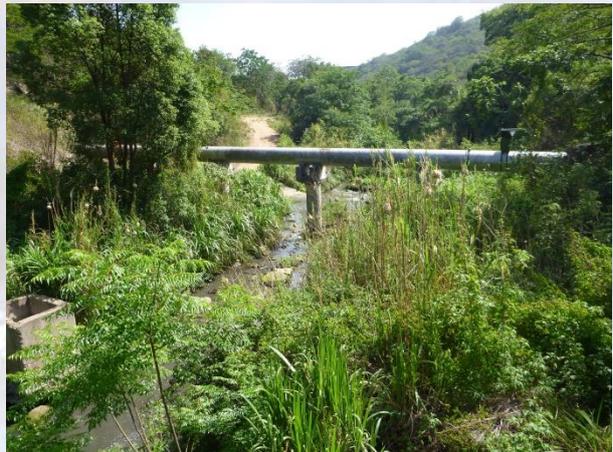
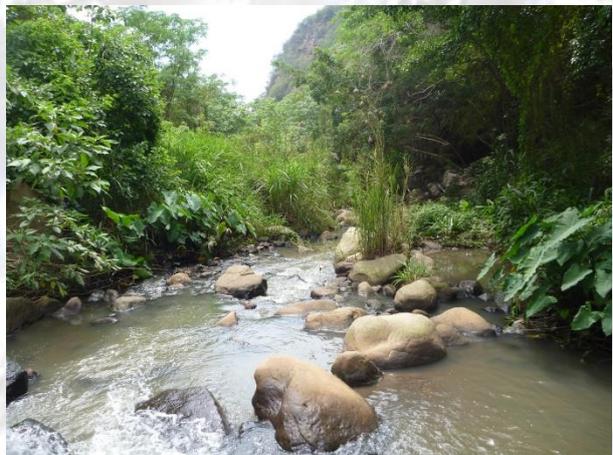
Top: View of valley through which the lower reaches of the Aller flows

Upper Middle: Water pipe crossing the Aller Valley

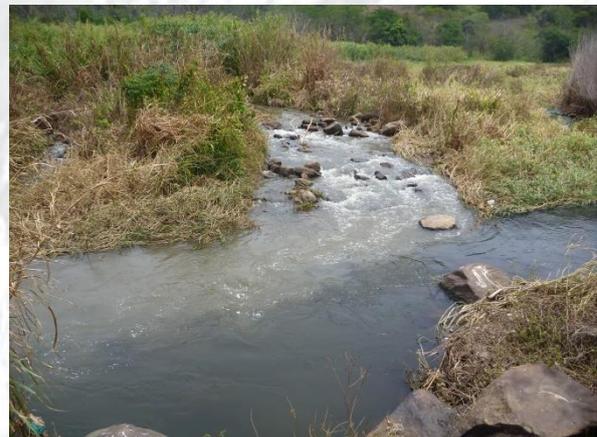
Between waypoints 33 and 27 one manhole was observed surcharging raw sewerage into the Aller River and a total of six manholes showed evidence of recent surcharges (wet faeces pooled and dried faeces stacked around and against the manholes or making a black trail away from the relevant manhole towards the river).

Lower Middle: Waypoint 21.5 – surcharging manhole

Bottom: Turbid Aller, clear uMngeni at confluence.

Sewer Monitors: We observed that the pipeline path from way points 33 to +- 24.5 has been kept cut open. In areas where there are no nearby homes, a local resident/s could be appointed to walk / ride a bicycle daily along given lengths of this pathway to inspect the pipeline and report any surcharges

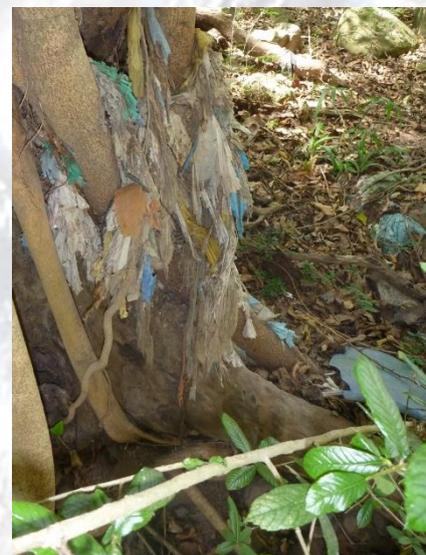
Middle: Dumped items in river bed

Bottom: Plastic waste left in tree by receding floodwaters, lower reaches

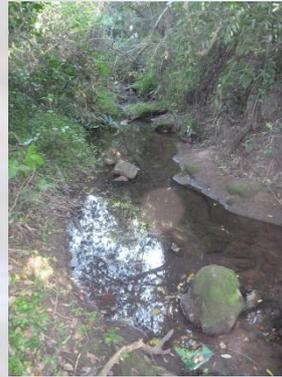
Site 2: Methylene Blue

Site description: At Mini SASS site approximately 100 metres downstream of the source

Indicator: Sample remained unchanged in 5 days indicating extremely low to no bacteria and conversely, oxygen levels of 80 to 100%. Thus the low Mini SASS score at the 1st test site is not caused by bacterial contamination

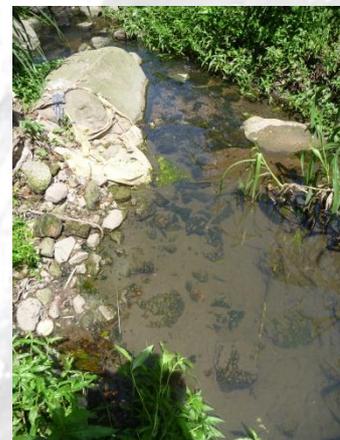
Site 4: Methylene Blue

Site description: Downstream boundary of New Germany Waste Water Treatment works, approximately 4 kilometres from source. Smell of chlorine

Indicator: Sample turned clear within 48 hours indicating high bacterial levels and little oxygen.

River Health negatively impacted due to: effluent releases of the New Germany WWTW

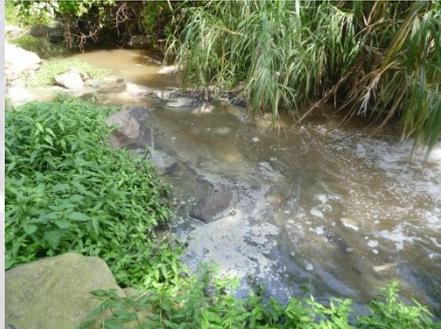
Site 5: Methylene Blue

Site description: Approximately 8.6km from source, slight smell of sewage

Indicator: Sample turned clear within 48 hours indicating high bacterial levels and little oxygen

River Health negatively impacted due to: sewerage from surcharging manholes

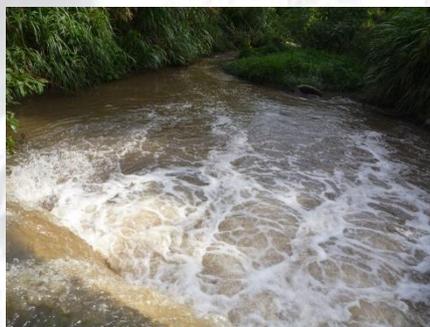
Site 6: Methylene Blue

Two samples were taken – the first from the Aller River water and the second sample from the uMngeni River.

uMngeni – Sample remained unchanged indicating high oxygen levels and low bacteria levels

River Health negatively impacted due to: sewerage from surcharging manholes
