# Lions River Walk Report

22<sup>nd</sup> to 29<sup>th</sup> September 2013

Compiled by Penny Rees  
Duzi uMngeni Conservation Trust (DUCT)  
March 2014

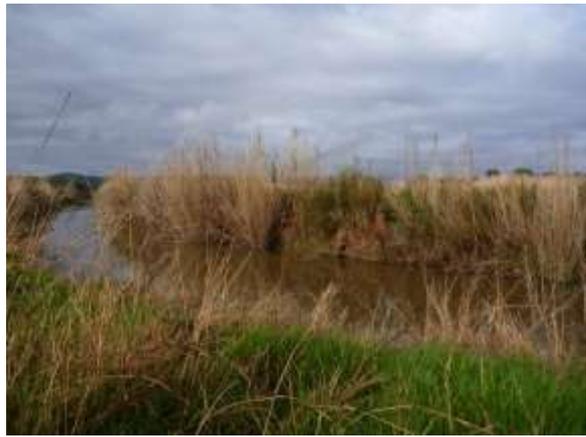
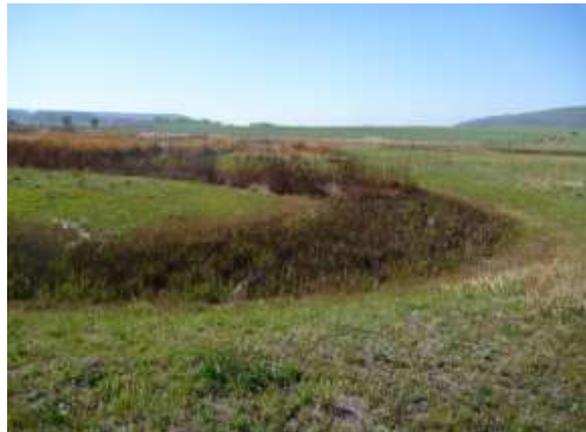
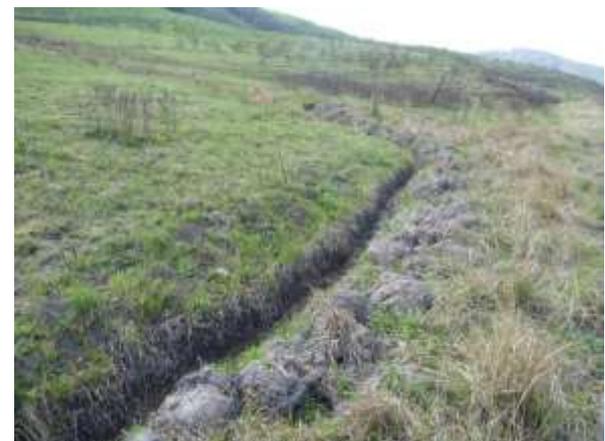
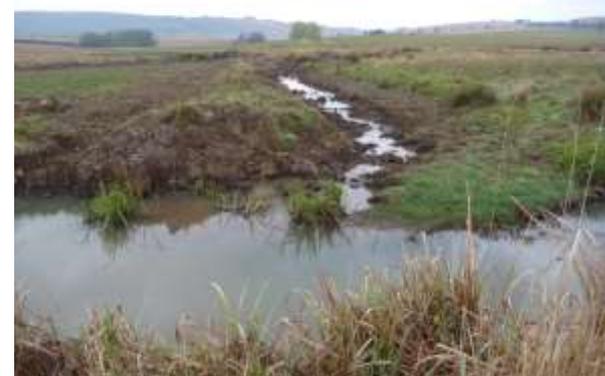
The majority of the wetlands along the Lions River are still drained by these historical ditches which vary in size from perhaps 60 centimetres wide by 40 centimetres deep, to as large as 2 metres wide and a metre or more deep.

*Bottom: Large wetland drain*

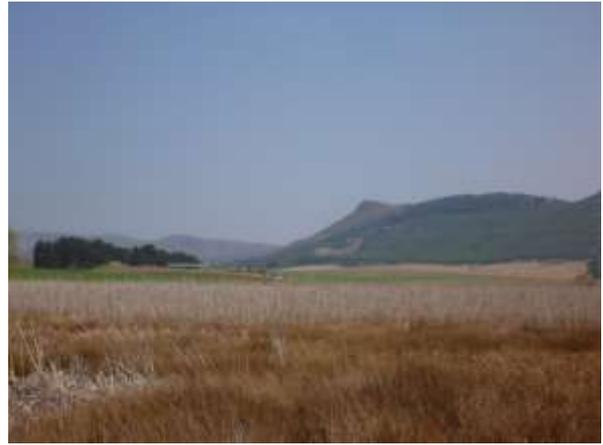
The largest (deepest and longest) drainage ditch on the Lions River wetlands is a diversion built many decades ago. Originally this section of river comprised a slow meandering current that spilt its waters over wetlands, countless horseshoe bends and oxbow lakes.

Today the diversion shortens the river by 2.2 kilometres, runs almost as straight as a dye and in its second half is deep enough that a freight train would not only fit in it, but would be hidden from the surrounding landscape. There is little sign of the original wetlands which have mostly been turned into arable lands.

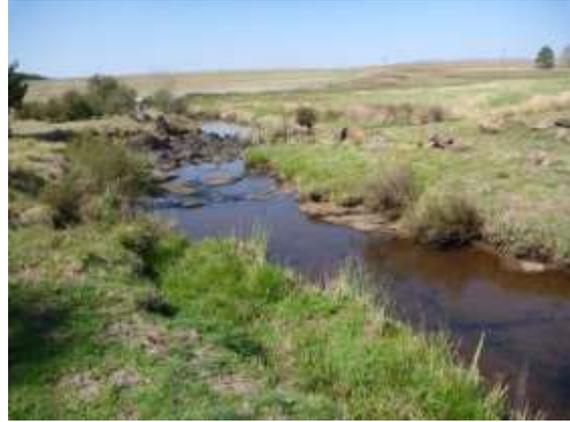
The Lions River is heavily extracted by agriculture and the Lidgetton and Lions River smallholdings. Subsequently, the river size 50 kilometres from the source (just upstream of the Mpofana / Lions confluence) does not look larger than it looks 15 kilometres from the source.

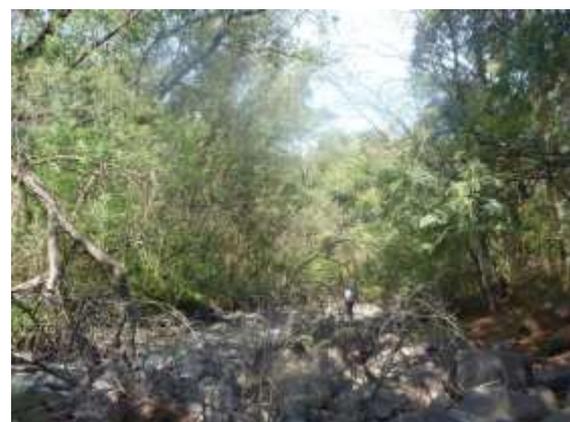
*Top: Lions River +- 15 kilometres downstream of its source*

*Upper middle: Lions River +-50 kilometres downstream of its source*

*Lower middle: Timber planted into wetland buffer*

*Bottom: Pine and self seeded wattle in river buffer*

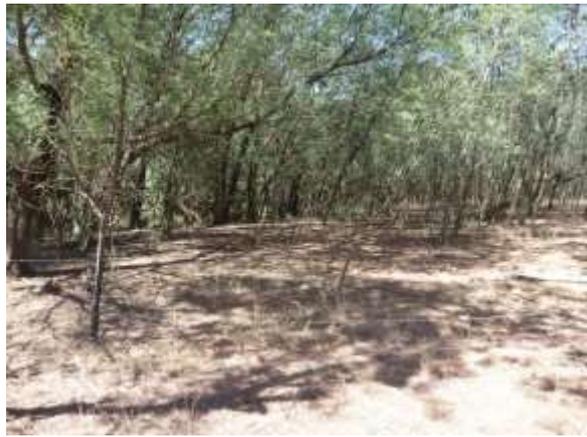
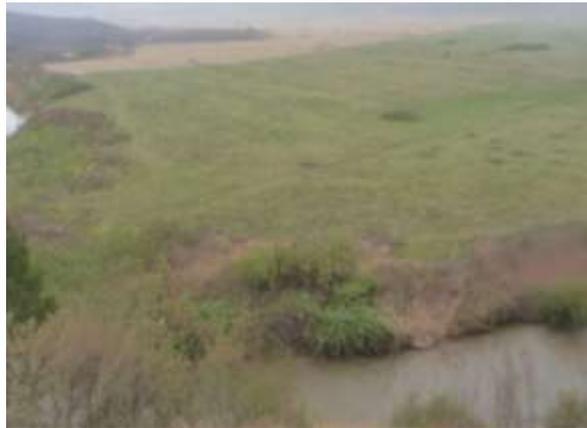
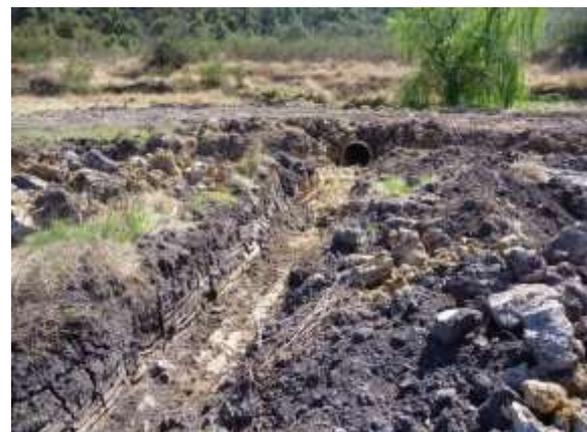
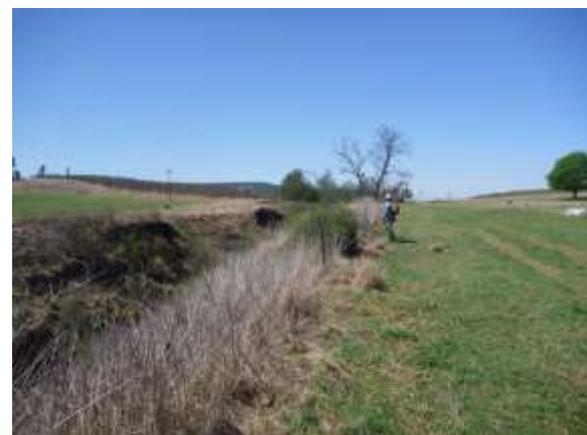
The aforementioned diversion has changed a section of the river irrevocably as the diversion channel runs straight as a die increasing in size and depth as it approaches a small escarpment where it ends in a wattle choked waterfall.

Prior to this diversion, the Lions River used to meander across a vast wetland in an eastern direction, then head south and then east again over a distance of just over 5 kilometres. The river now flows for just under 2 kilometres along a straight channel from the north west to the south east with dykes on some banks, and no sign of the original wetland which is now planted to kikuyu pastures.

*Top: Wattle choked river bank*

*Upper Middle: Network of disused wetland drains*

*Bottom: River diversion*

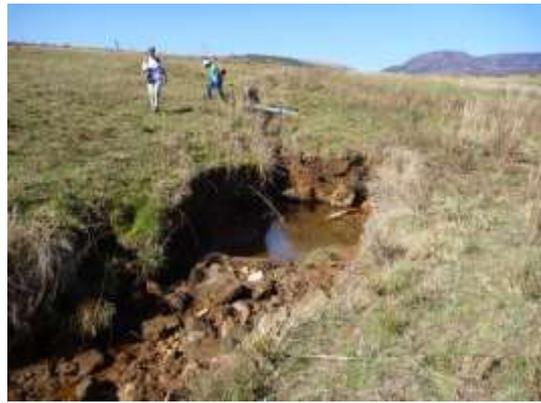
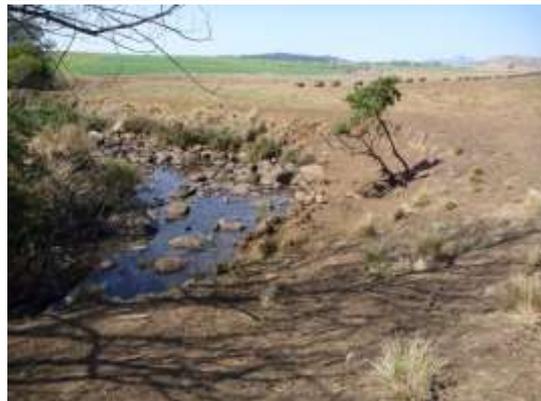
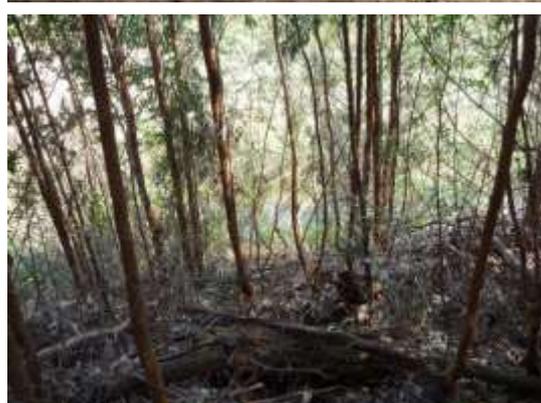
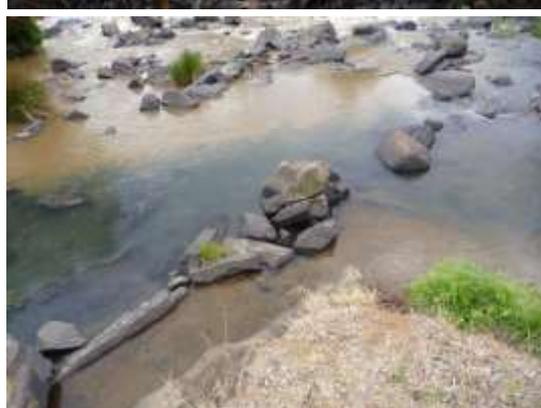
*Top: Erosion at earth dam overflow*

*Upper middle: River banks trampled bare by cattle*

*Bottom: Silted Mpofana meeting clear Lions*

Water is gravity fed via a pipeline from the Mearns Weir on the Mooi River, then released into the Mpofana which was previously a small stream. Thus due to the now regular high volumes of water the banks of the Mpofana are eroding badly causing heavy turbidity in the stream. All this silt is transferred into the Lions River at the Mpofana / Lions confluence. Between the confluence and the Lions River settlement, the Lions River is being eroded to such an extent that some of the banks have been shored up with stone gabions. This seems to be having limited success. This situation will be exacerbated when the transfer from the new Springrove Dam on the Mooi River begins, as the release levels will be higher.

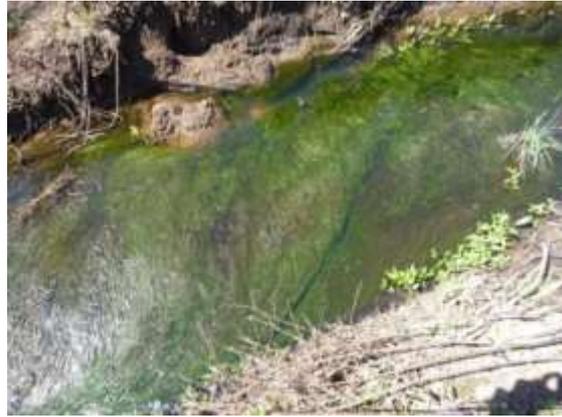
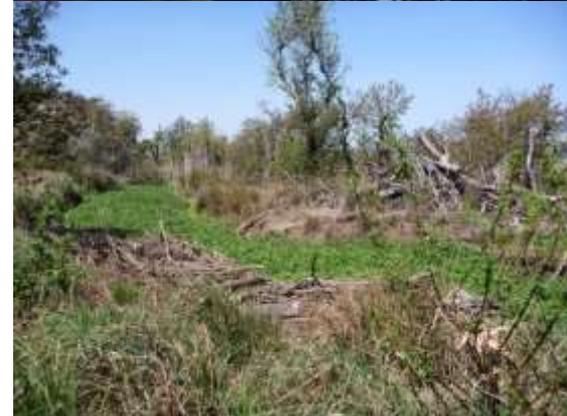
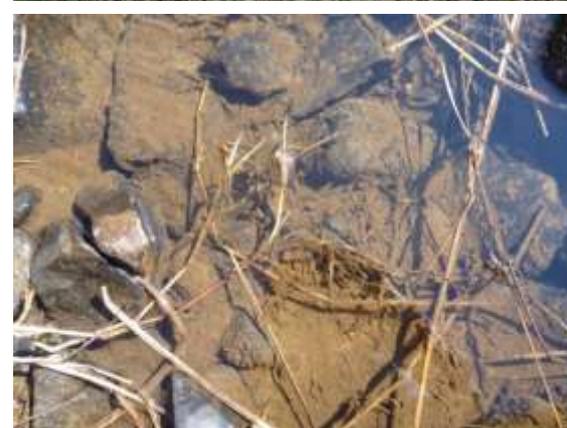
*Top: Possible Potamogeton*

*Upper middle left: Fine Oxygen Weed*

Seen regularly down the Lions was the presence of large quantities of Potamogeton (Pond Weed) and Lagarosiphon muscoides (Fine Oxygen Weed) in the dams, Myriophyllum aquaticum (Parrots Feather), Nasturtium officinale (Water Cress) and bright green patches of algae. Elevated levels of diatoms (were also noted

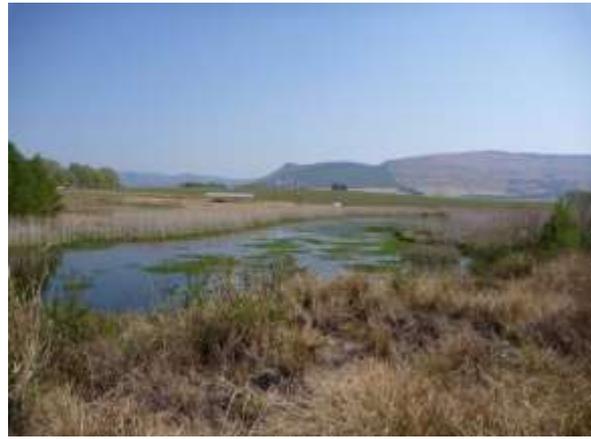
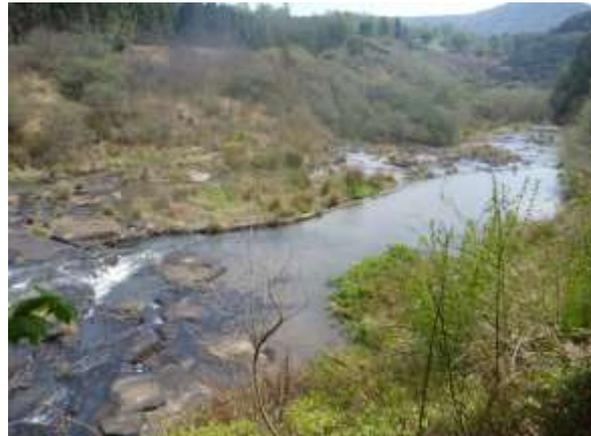
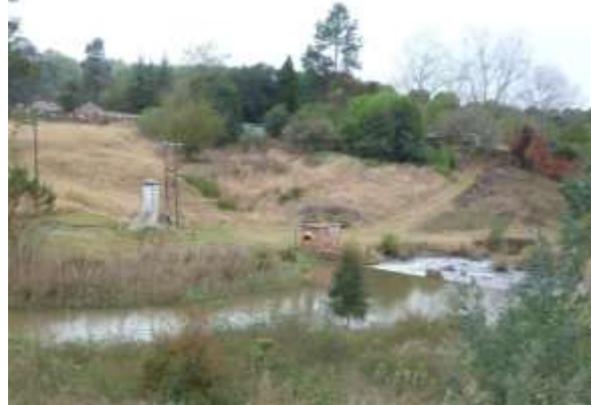
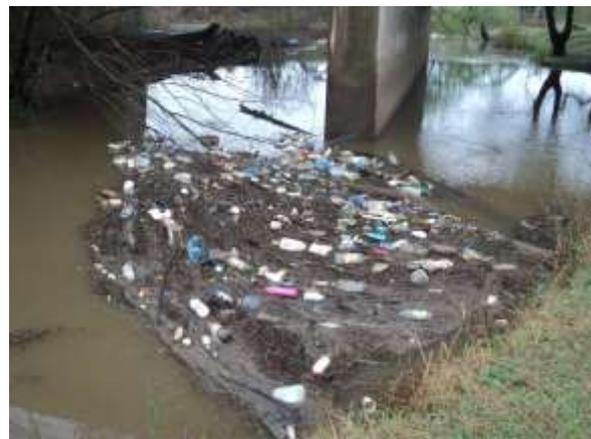
Dams negatively impact on river health by reducing flows, depositing water of a different temperature into the river and depositing silt either via outlet releases or when changing water temperatures during spring and autumn cause currents that stir up detritus on the dam bed.

*Top: Large dam on upper reaches of the Lions River*

*Upper middle: Historical trout dam*

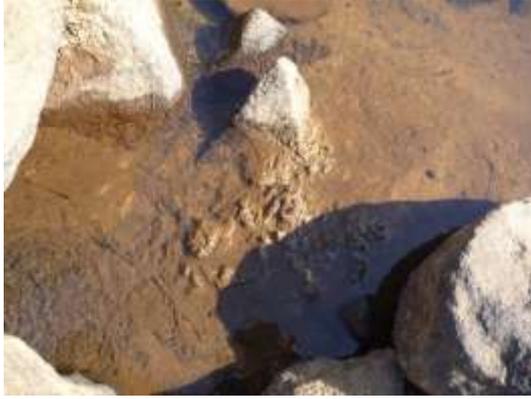
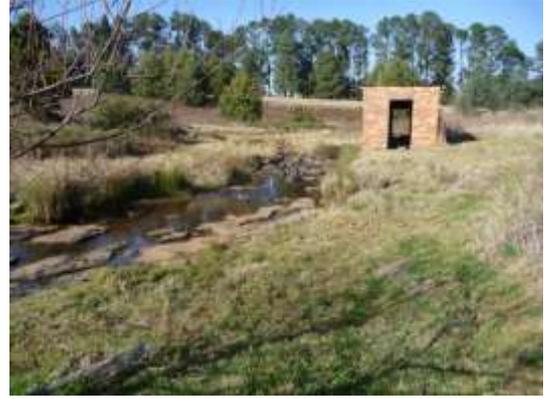
*Mini SASS score:* 5.2 Largely modified POOR condition

*River Health negatively impacted* due to two large earth dams and elevated nutrient levels. The site is situated a few hundred metres downstream of a confluence of two rivers, each river with a large earth dam a few hundred metres upstream of the confluence.

- Low water level in river due to upstream dam
- We did not see the second dam wall, however from the small size of river at the test site it would seem that the second dam also has very minimal releases
- Immediately below the upstream dam wall the river surface was smothered in Parrots Feather, an indicator of elevated nutrient levels.
- Algae in water indicated elevated levels of nutrients, the origin of which we were unable to identify – there were no signs of livestock accessing the river, nor signs of effluent from the poultry farm.

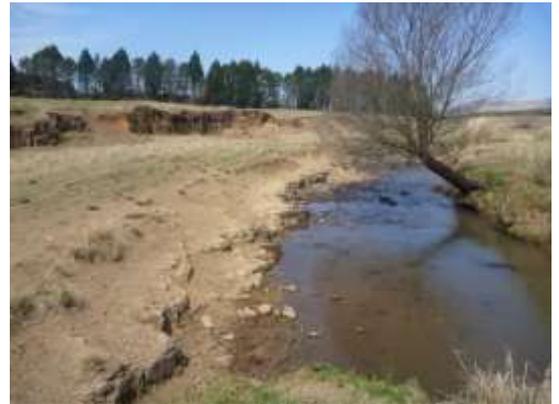
*Mini SASS score:* 6.2 Moderately modified, FAIR condition

*River Health negatively impacted* due to the lack of an intact riparian buffer - no natural riparian vegetation, quarry on edge of buffer, kikuyu pastures

- Livestock access to river resulting in bank sheet erosion and siltation of river bed from cattle trampling
- Low water level in river due to upstream water extraction and dams

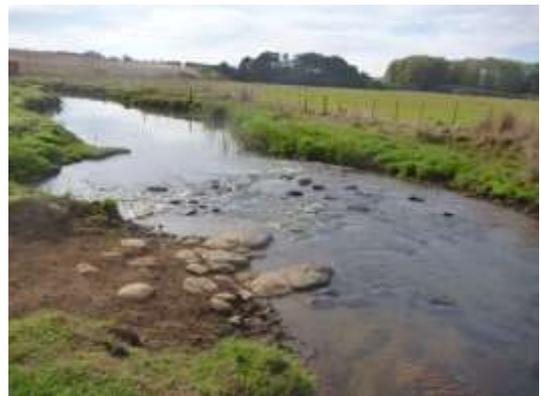
*Mini SASS score:* 6.1 on the edge of moderately modified, FAIR condition & largely modified POOR condition

*River Health negatively impacted* due to the lack of an intact riparian buffer – kikuyu pastures

- Although the majority of the river on the property is fenced off from livestock, the test site has been trampled by cattle accessing the river causing bank erosion and siltation of the river bed

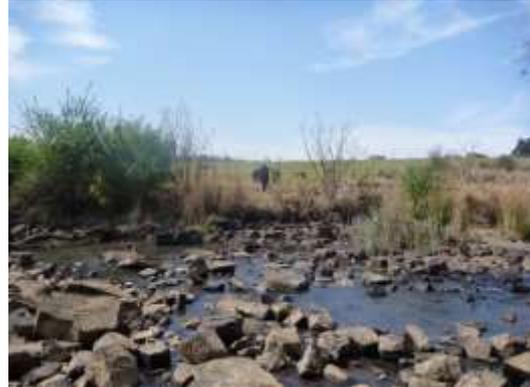
*Mini SASS score:* 6.4 Moderately modified FAIR condition. Highest score on Lions River

*River Health negatively impacted* due to the lack of an intact riparian buffer – Pine trees and kikuyu pastures

- Livestock access to river resulting in bank erosion and siltation of river bed from cattle trampling
- Layer of pine needles on river bed
- Acidification of soil and water by pine needles
- Low water level in river due to upstream water extraction and dams

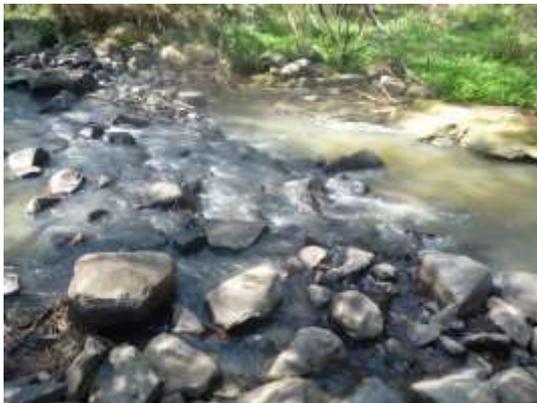
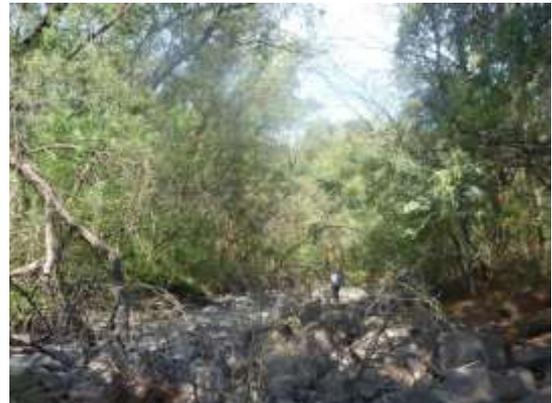
*Mini SASS score:* 6.1 on the edge of moderately modified, FAIR condition & largely modified POOR condition

*River Health negatively impacted* due to the lack of an intact riparian buffer - Wattle trees and some Bug Weed and Wandering Jew. The wattle trees are so dense that they shade the river and they change the pH of the water and soil

- Low water level in river due to upstream water extraction and dams

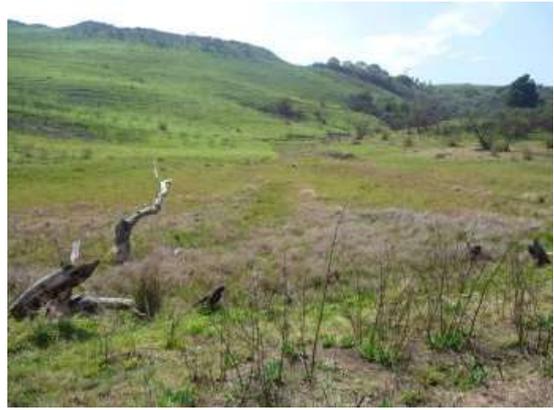
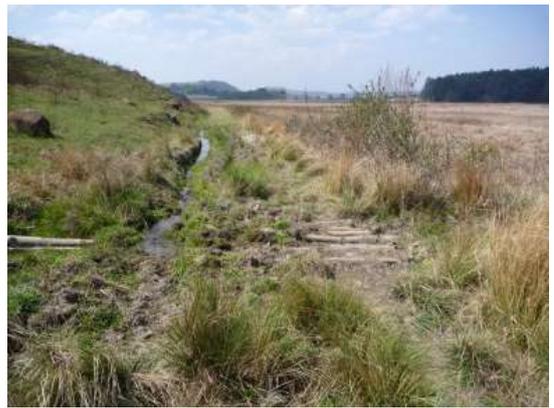
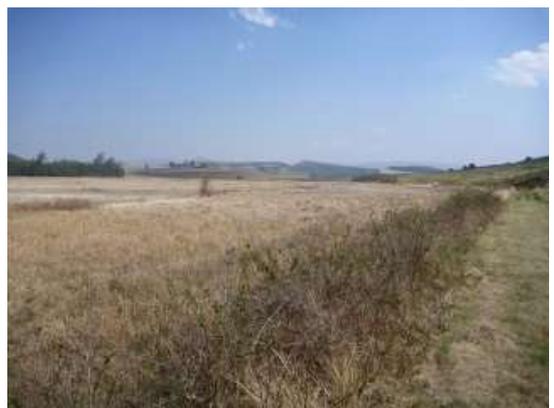
On the upstream section of the area, grassland hills rise from the western edge of the wetland. These hills have numerous seeps draining to the wetland. The ecotone between hills & wetland has been dyked, effectively damming the hillside seeps which have also been trenched, preventing the water from spreading onto the wetland. A light infestation (+- 5 metres width) of bramble is growing on the edge of the road / wetland in the ecotone / wetland edge

Although this area is beyond the riparian buffer, the rehabilitation of these wetland drains will contribute tremendously to the rehabilitation of the main wetland (Area 8 above)

*Top: Grassland hills to west of wetland*

Rehabilitation would comprise the following:

- The rehabilitation of drains in the wetland / floodplain on both banks
- the removal of a small dyke which acts as a barrier to hillside seeps and wetlands (left bank)
- the removal of the road on the ecotone between hill toe and floodplain (left bank)
- the removal of the mostly small drains at the foot of the hillside (left bank)
- the removal of a small infestation of bramble along the road edge and on the floodplain (left bank)
- the protection of the natural grasslands on the hillside (left bank)
- the protection of the small water courses and their associated intact riparian vegetation that occur on the hillside (left bank)

We feel these few measures will enable the small wetlands at the foot of the hill (left bank) to then spread out onto the wetland / floodplain which will in time revert to a proper wetland.

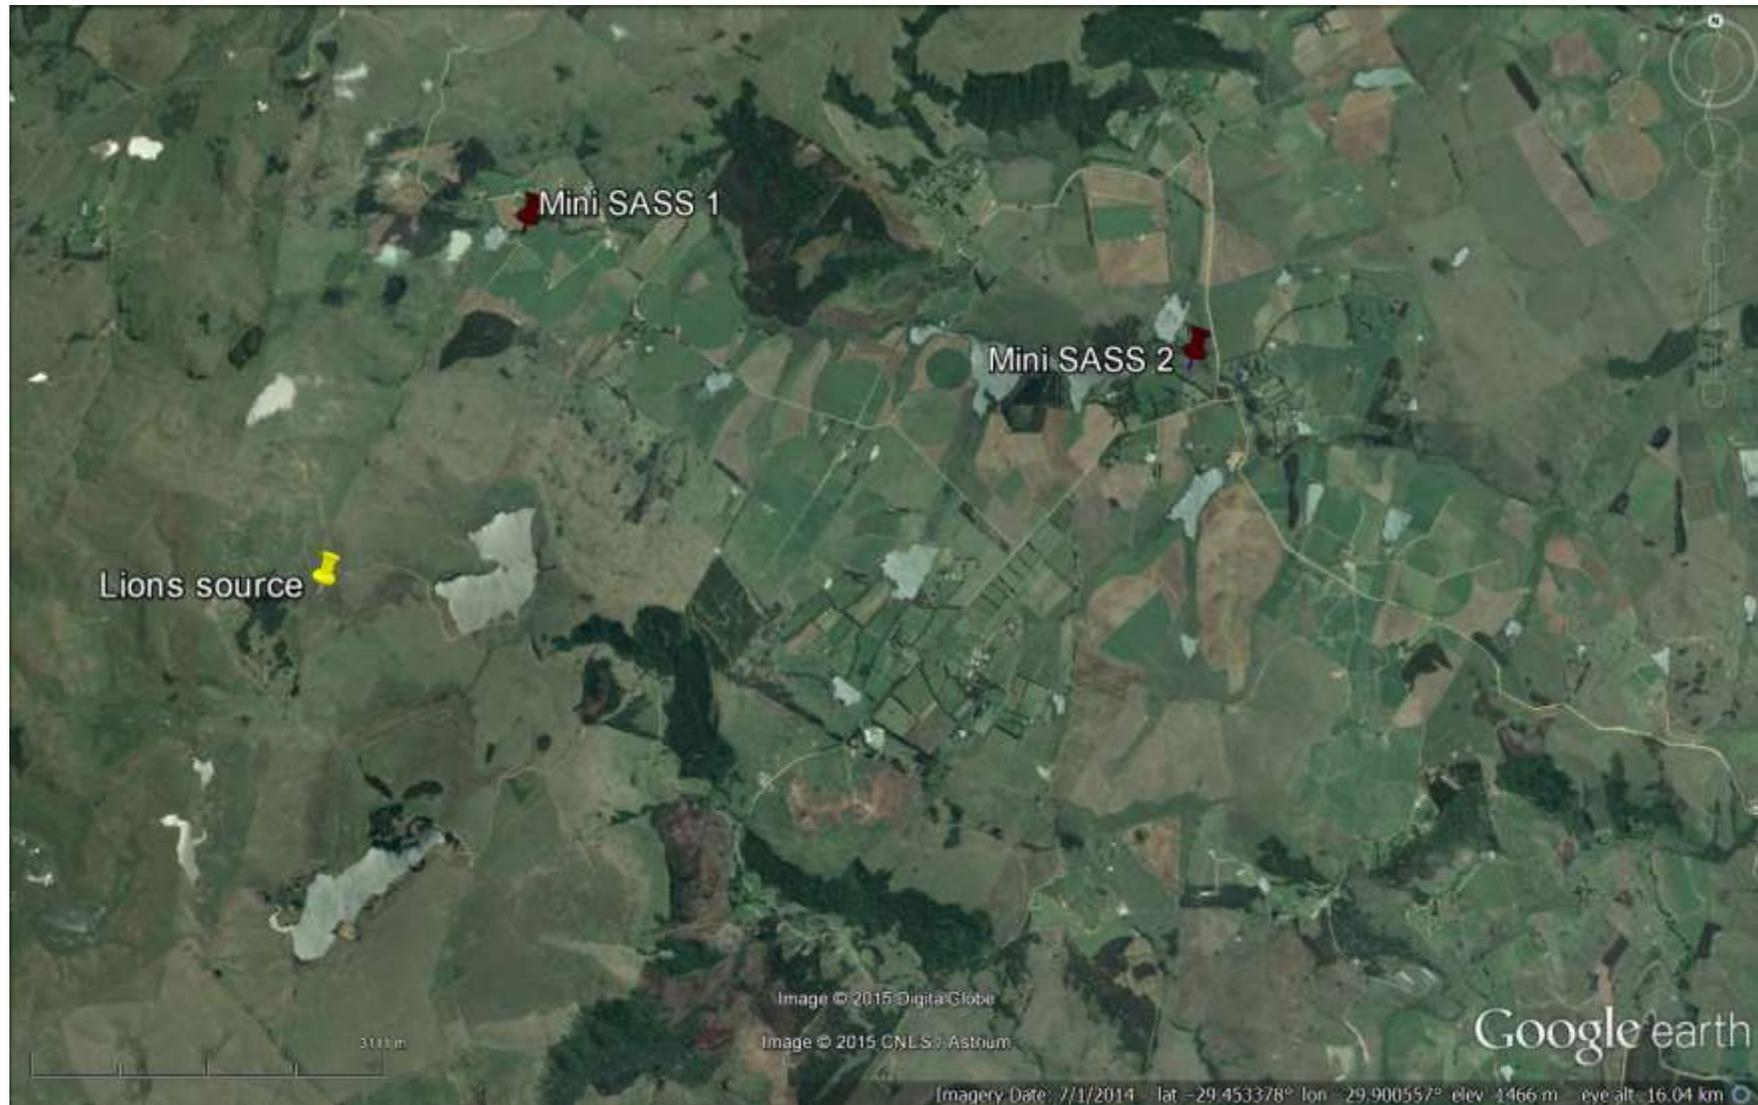
Site 1	4.6 Critically modified, Very poor condition
Site 2	5.2 Largely modified, Poor condition

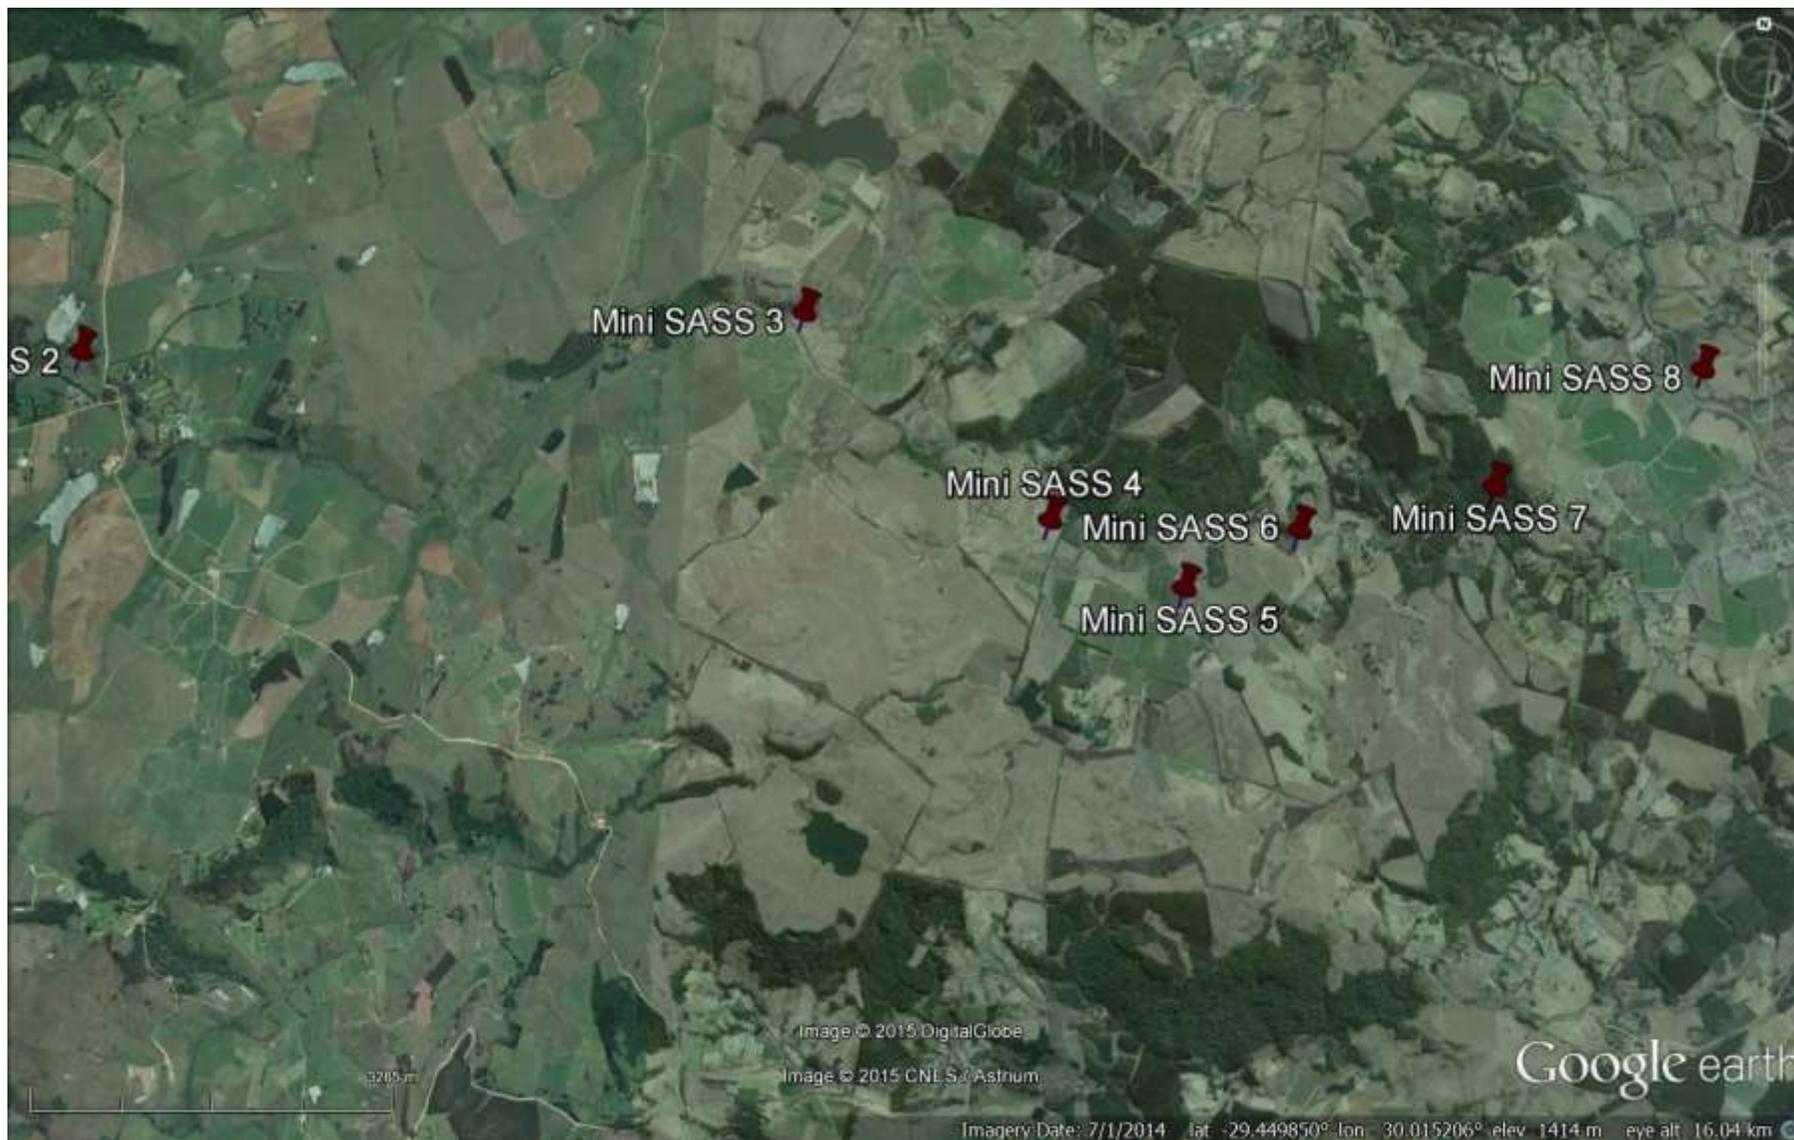
Site 3	5.1 Critically to Largely modified / Very poor to Poor condition	Site 6	6.4 Moderately modified, Fair condition
Site 4	6.2 Moderately modified, Fair condition	Site 7	6.1 Moderately to largely modified / Fair to poor condition
Site 5	6.1 Moderately to largely modified / Fair to poor condition	Site 8	5.2 Largely modified, Poor condition
